DISCIPLINARY COMMITTEE – UPHELD COMPLAINTS LESSONS TO BE LEARNT

CASE STUDY
FEBRUARY 2023 – BOUNDARY CUT

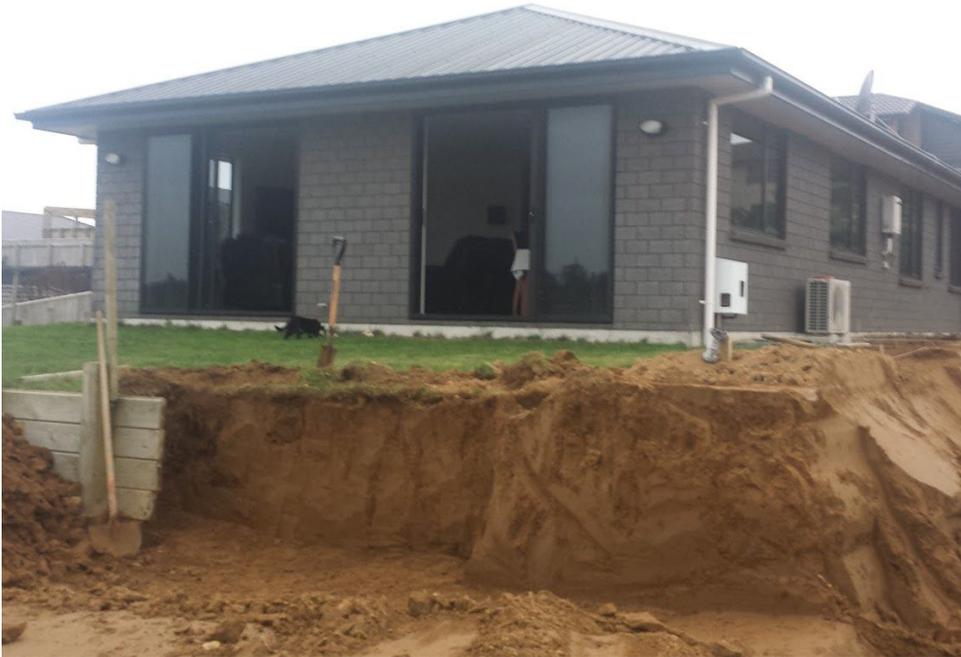
Figure 1: Image taken late March 2016

The developer made a 1.2–1.7m vertical cut (see figures 1 and 2) on the boundary between the subdivision and the complainants' property, creating a falling hazard and potentially undermining the foundation of the complainants' dwelling (see figures 5 and 6). The complainants were concerned the engineer was either unaware of the cut being made or acted incompetently in allowing the cut to be made. The engineer stated his last site visit was approximately three weeks before the cut was made.

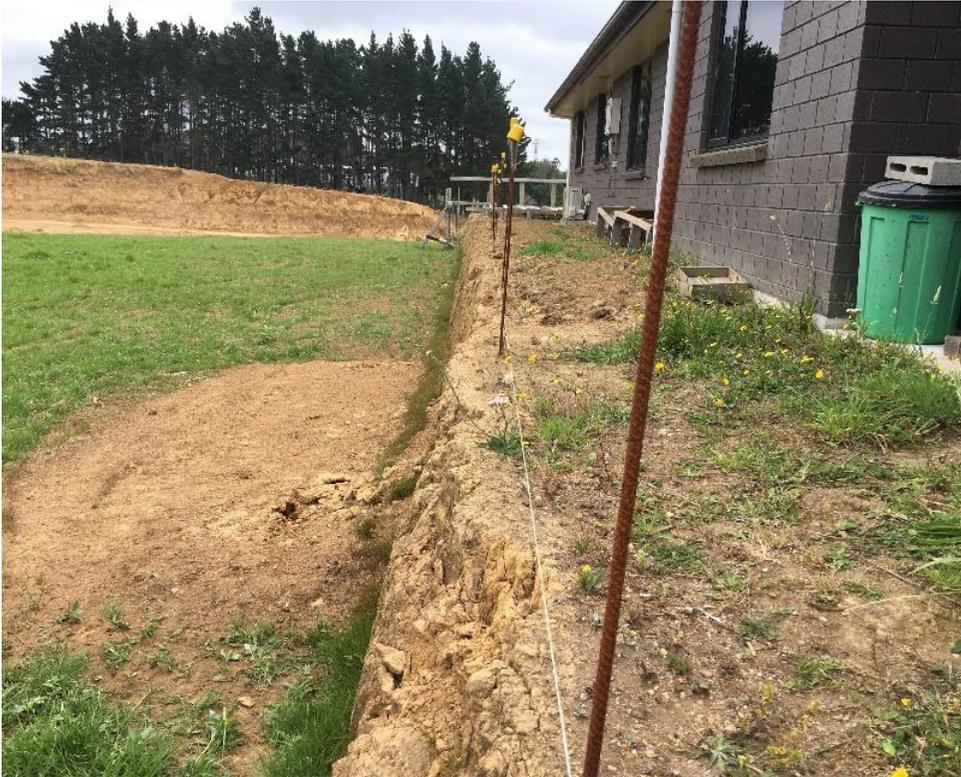
The complainants believed the remedial works the engineer designed and oversaw to repair the cut (see figures 3 and 7) were inadequate and did not resolve the problems caused. They also believe the engineer responded inadequately to their concerns.

The complainants raised their concerns about the cut with the engineer and their local council in 2018. The Council issued a Notice to Fix to the developer, requiring the installation of a retaining wall along the boundary. A second notice was issued in November 2018 instructing the developer to reinstate the ground. The developer installed soil buttressing along the toe of the cut to "flatten" the grade-line from the bottom of the bank to the adjacent building (see figure 3).

Figure 3: Image taken February 2019 – note remedial fill at the toe

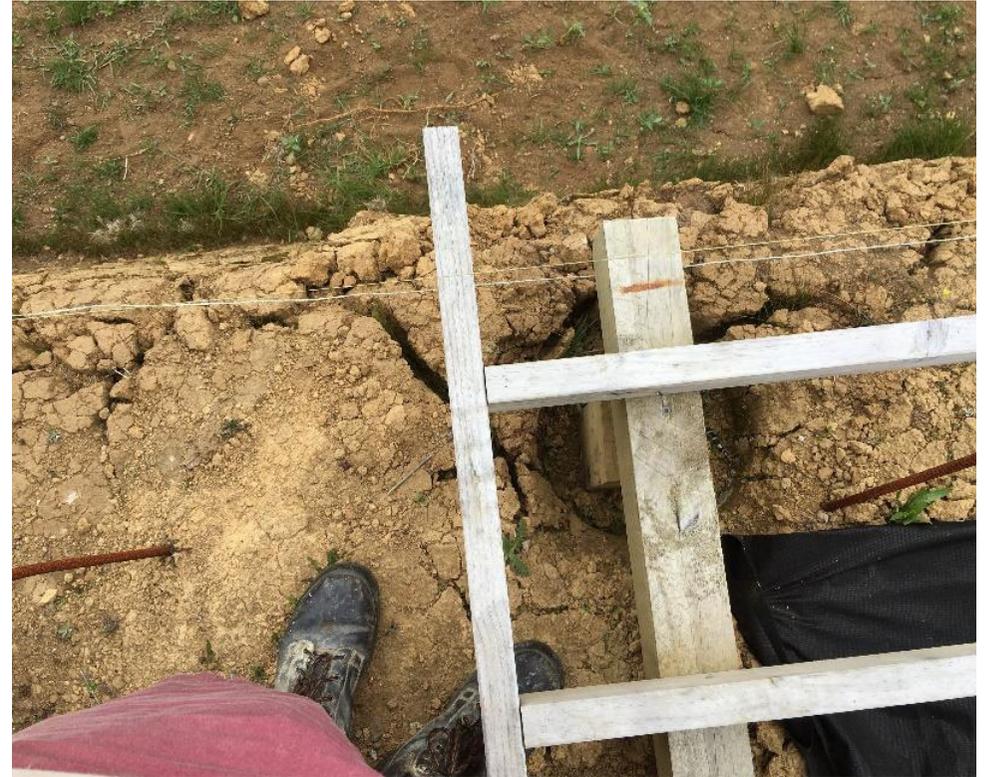
In March 2016, the developer undertook earthworks at a new subdivision and made a bulk excavation vertical cut on the boundary between the subdivision and the complainants' property. The complainants say the cut left their property unsafe, unsupported, and unable to be fenced. The complainants communicated frequently with the developer to try and resolve the issue by building a retaining wall. Over time, the bank frattered due to weathering (see figures 3 and 4).

Figure 4: Images taken February 2019 – soil cracking at the top of the cut
