OROVILLE DAM INCIDENT - 2017 LESSONS TO BE LEARNT

December 2021

This document summarises the webinar by Brian Benson and David Menéndez Arán who discuss lessons to be learnt from the 2017 Oroville dam incident in California. These are relevant to engineers of all disciplines.

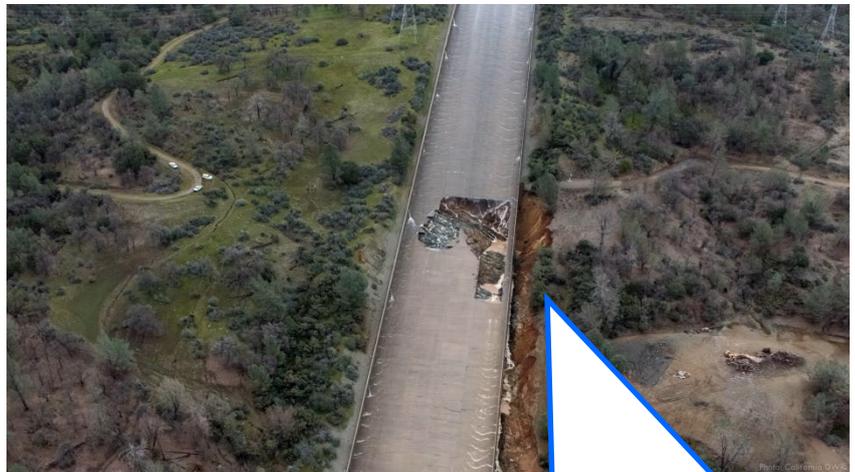
The Independent Forensic Team (IFT) determined that failure was likely caused by stagnation-driven uplift pressures as high-velocity water was injected into the drainage system through open cracks and joints. The chute was susceptible to this failure mode due to extensive cracking along the entire chute formed in line with the drainage system.

After the spillway gates were closed, the condition of the spillway was assessed. Note the missing and broken chute slabs and the erosion progressing behind the left sidewall.

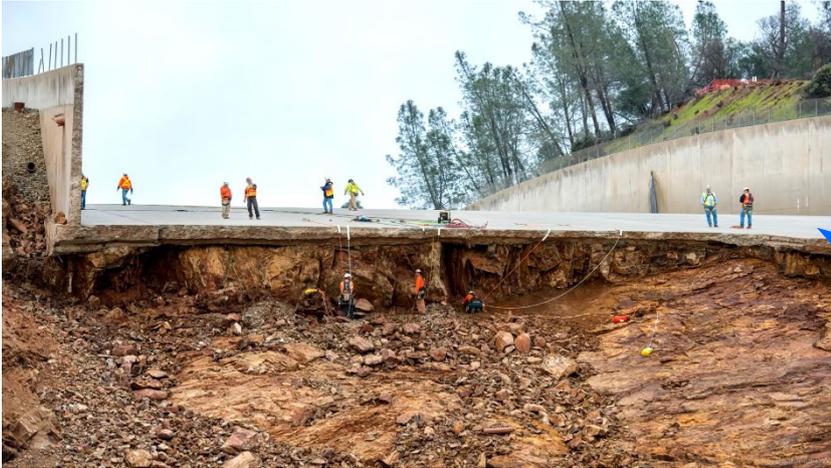
Inspection of the problem area when spillway gates were closed. Note relatively thin slab and erosion of the weathered foundation rock.

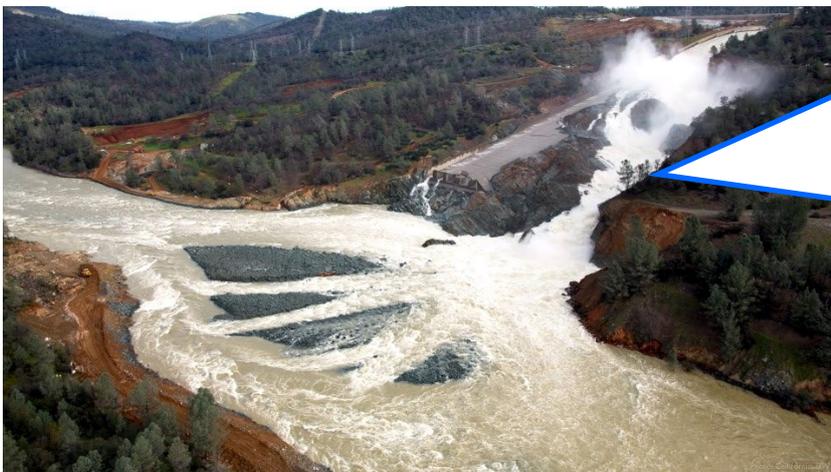
1. Debris was accumulating on the river channel, raising tailwater levels and threatening to flood the powerhouse.
2. Chute erosion could affect the transmission line crossing over the spillway.

Alternative flow channel formed by erosion after failure of the spillway chute. Note the debris in the river channel, which was responsible for raising tailwater levels.

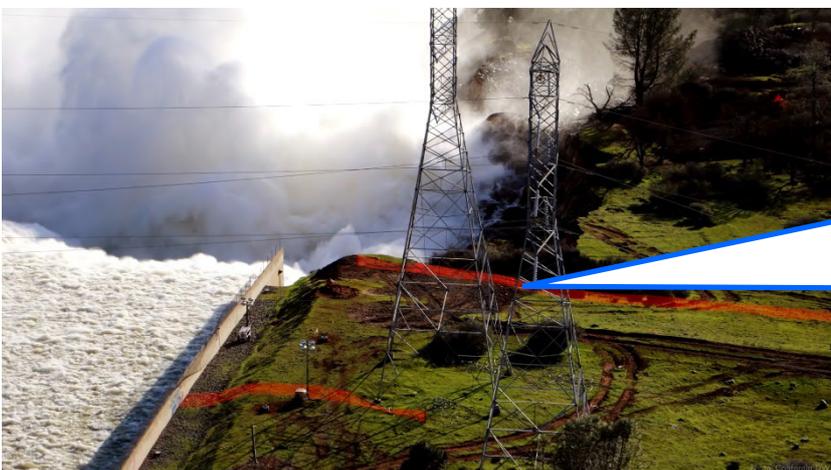
The erosion came close to the transmission towers but did not undermine the structures.

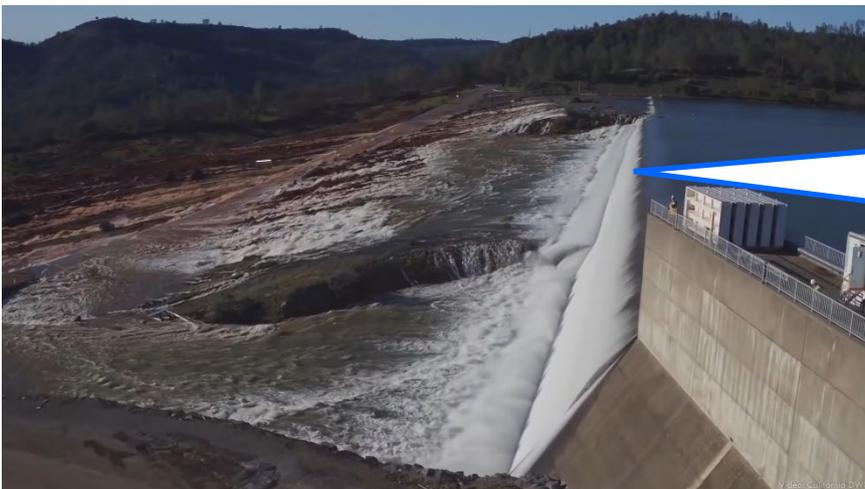
Emergency spillway in operation.

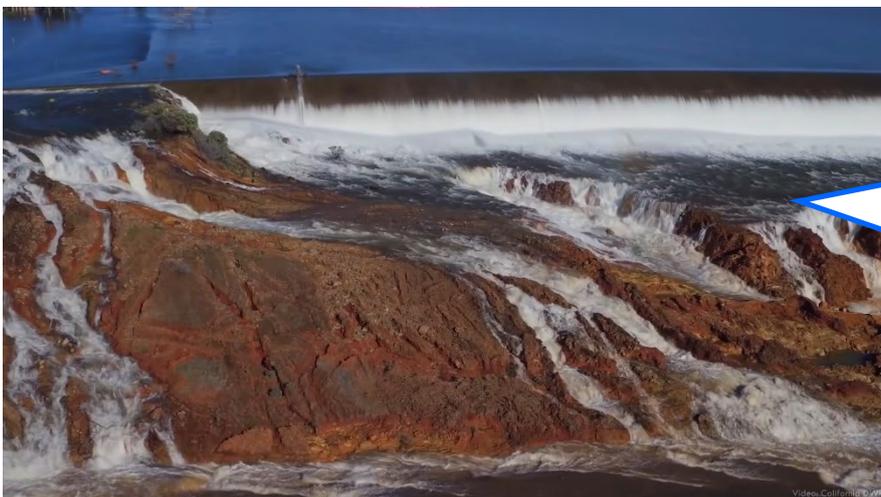
Despite this advice, the emergency leaders decided to close the service spillway gates and allow overtopping of the emergency spillway. Greater erosion than expected was noted on hillside soon after. Headcutting progressed rapidly towards the concrete weir. Left unchecked, this could have led to the emergency spillway being breached.

Erosion progresses as flow concentrates in channels forming downstream of the concrete weir.
