DISCIPLINARY COMMITTEE – UPHELD COMPLAINTS LESSONS TO BE LEARNT

CASE STUDY
AUGUST 2023 – FIRE REPORT

FIRE ASSESSMENT IN ACCORDANCE WITH C/ASL (2005)

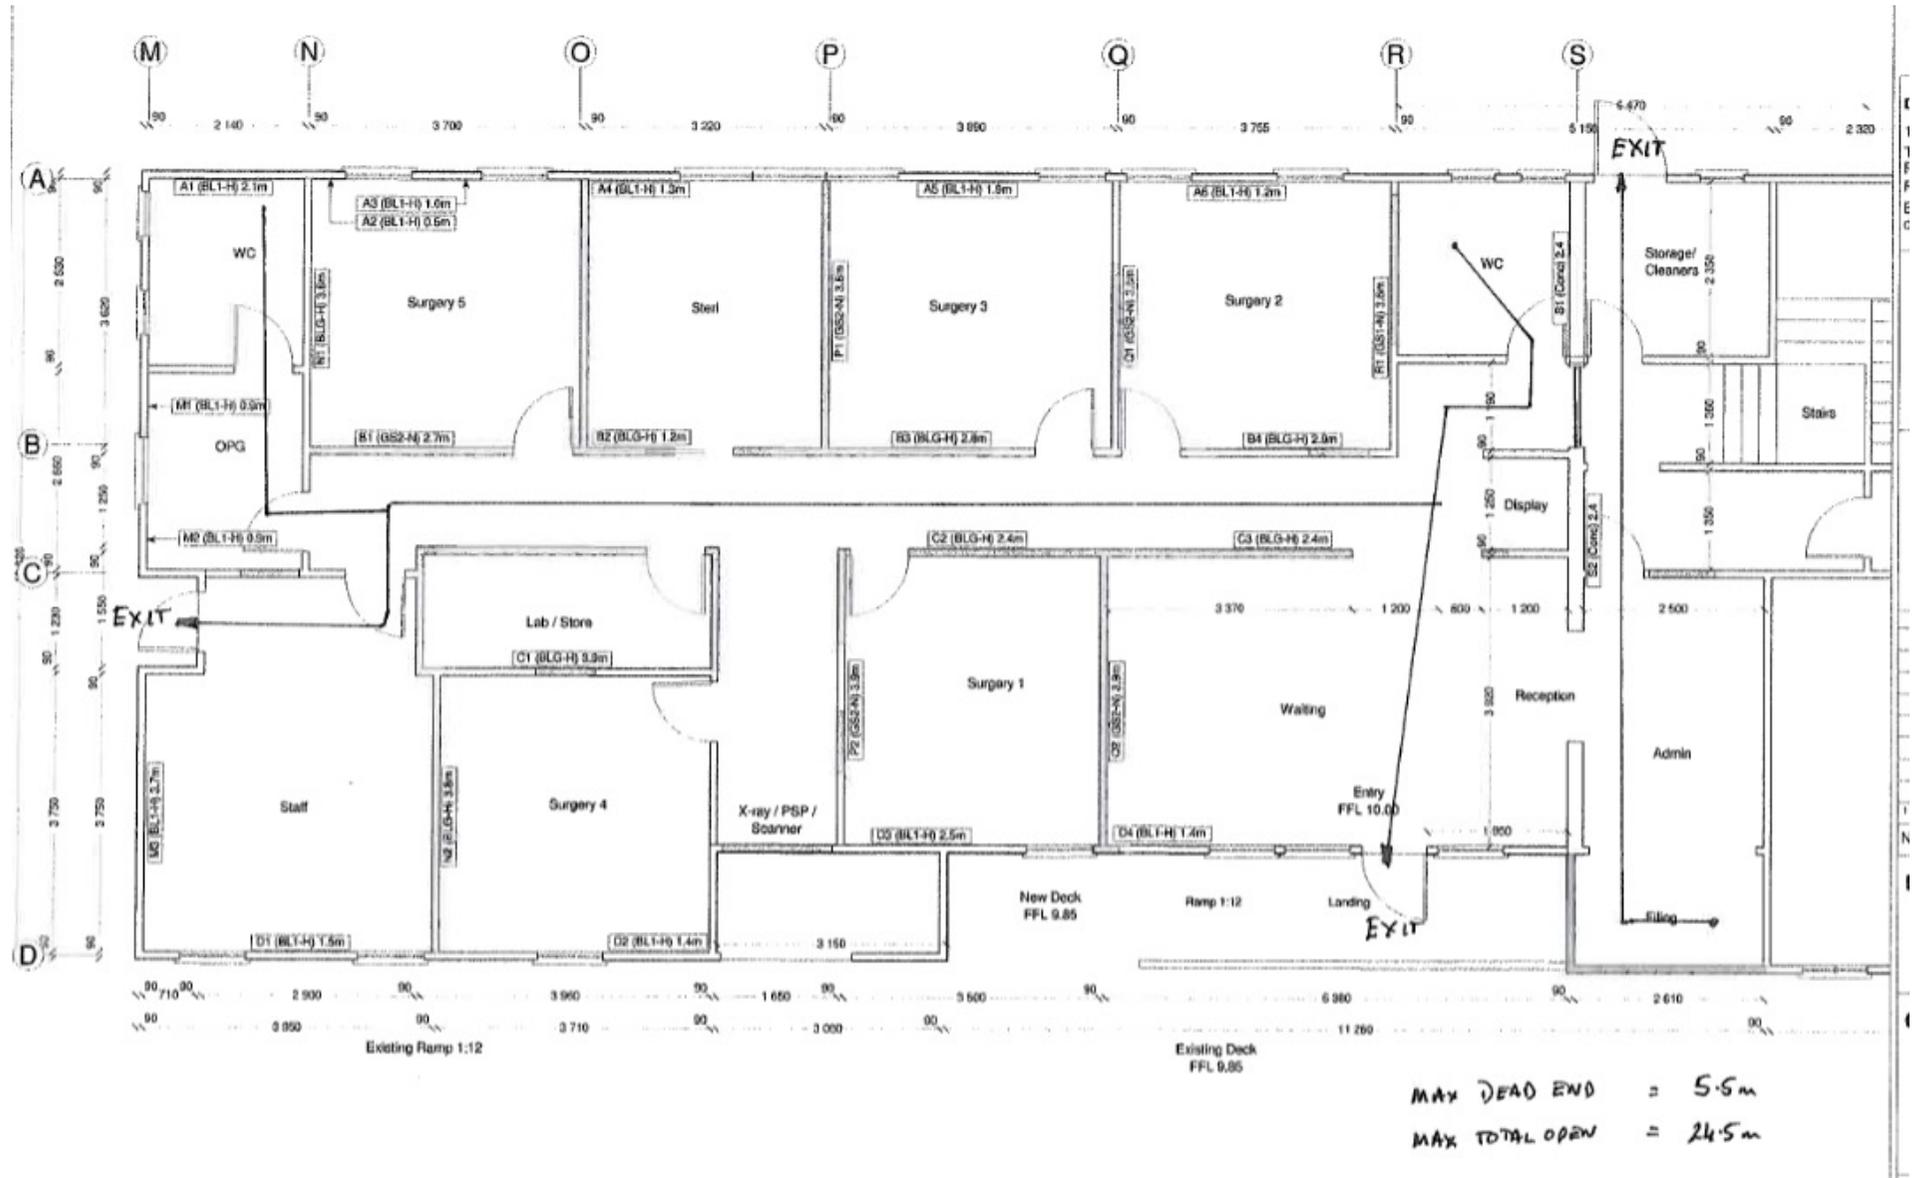
Figure 1: Original report – proposed fit out solution.

The report was slightly longer than a page and included a floor plan of the area of work and some escape route lengths. The report omitted the following.

1. The work being undertaken was an alteration to a building and that Section 112 of the Building Act applied.
2. Assessment of means of escape for the rest of the building.
3. The current version of the Acceptable Solution to use was Amendment 9 rather than Amendment 5 referenced in the report.
4. No discussion of fire separations, number of floor levels or population in each firecell.
5. No justification for the required fire safety precautions.

Section 112 of the Building Act requires that ‘the building’ complies with the provisions of the building code for means of escape from fire, as nearly as is reasonably practicable, and continue to comply with other provisions of the building code to at least the same extent as before the alteration. Section 112 does not limit the scope of assessment to just the area of work but addresses the entire building.

Apart from a simple “statement of change”, the more rigorous assessments require an understanding of the current state of the building to be able to compare how the building is currently constructed and used with what would be required if it were a new building. Most of this information can be found on existing plans and fire reports, however the state and use of a building can change over time. It is good practice to carry out a building inspection to ensure that the layout is as per the known plans, that the fire safety systems are as stated in previous fire reports and that fire separations are in the correct locations, fire doors are in operation and any easily visible passive fire is compliant. If the fire report author had undertaken a site visit, they would have determined that one of the fire exits was no longer available. This is a fundamental feature of the egress design.

By following the documentation guidelines in Practice Note 22 and carrying out a site visit the fire report author would have been in a much better position to demonstrate to the BCA how the alteration would comply with Section 112 of the Building Act. For current fire report authors carrying out Section 112 assessments, the MBIE guidance is also an invaluable tool for determining the level of rigor that needs to be applied to an assessment.

1. Verify the current state of the building by
 - a. review previous consents (council property file)
 - b. conduct a site visit
2. Use the MBIE guidelines for “Requesting information about means of escape from fire for existing buildings” and attach the score sheet to the fire report
3. Have a fire report template(s) with all the necessary headings pre-prepared to complete
4. Check the MBIE website for the latest compliance documents which are free to download.
