# ENGINEERING HERITAGE

**Proceedings of  
Second Australasian Conference  
on  
Engineering Heritage  
Auckland  
14-16 February 2000**

**Edited by:  
R.F. Hill and P.G. Lowe**

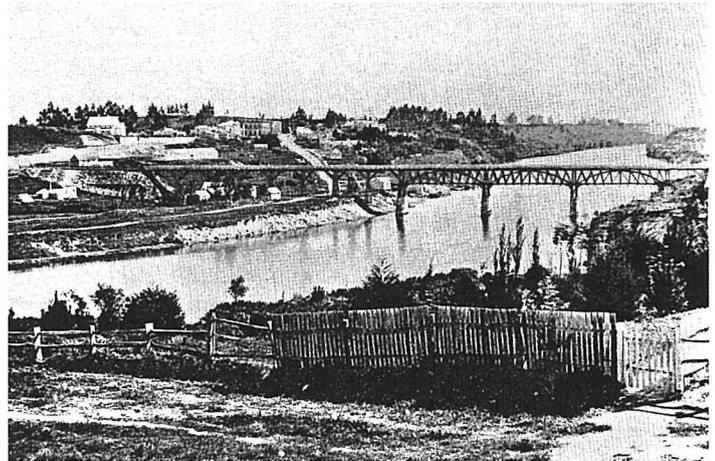
*Union Bridge*

The first bridge across the Waikato River, built in 1878, was a timber structure built from kauri and called the Union Bridge. It provided a one-lane crossing for horse and cart traffic and was initially a "toll" bridge. It served the City until 1910 when it was demolished after the "new" Victoria Bridge was

The timber piles were cut off at "bed level" and are still there today – they can cause a problem for unsuspecting boaties when the river level is very low.

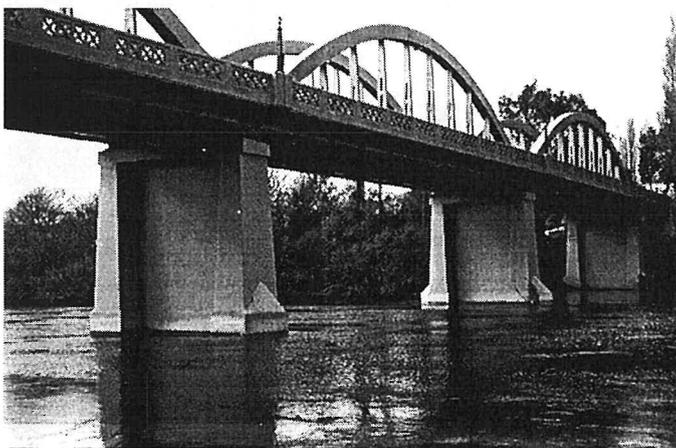
*Fairfield Bridge*

The Fairfield Bridge is a 3 span concrete bowstring arch bridge that was opened in 1937. It was the fourth concrete bowstring arch traffic bridge in New Zealand, the others being at Tuakau across the Waikato River; the Fitzherbert Bridge across the Manawatu River at Palmerston North and the Balclutha Bridge across the Clutha River. The Fitzherbert Bridge has been demolished.

It is so important that the bridge owners, whoever they may be in the future, understand the key features of these bridges and pay attention to their maintenance. For both Victoria Bridge and Claudelands Bridge the key criteria that will affect their life are metal fatigue and localised corrosion. For Fairfield Bridge it is maintaining the waterproofing to keep the concrete dry and inhibit the concrete cancer.

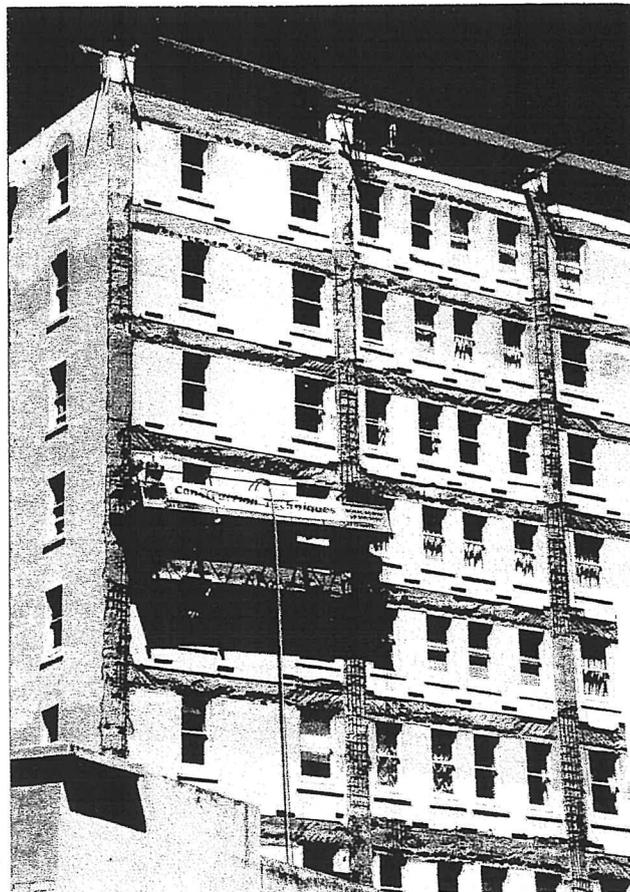
*Fig 4: Westminster Court Apartment – state of the concrete and reinforcement prior to the repair and application of a CP system – 1989*

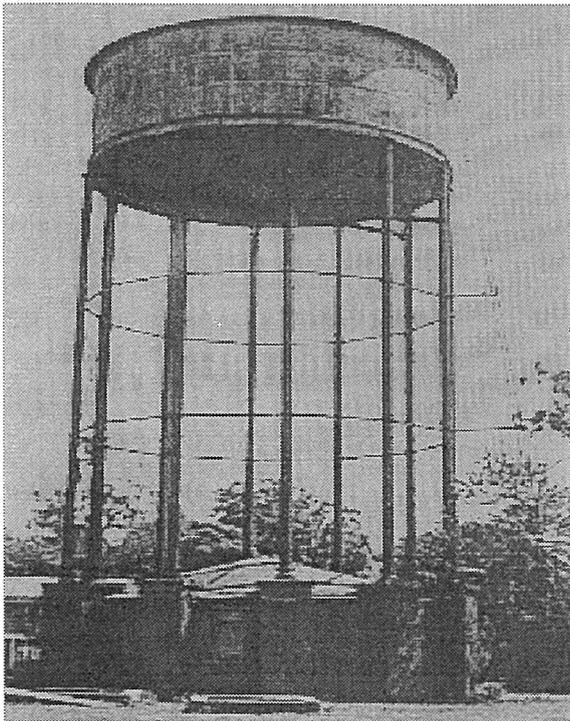
*Fig 1 The original 1883 tower with blacksmith shop under*

The original water tower is a 6 metre diameter riveted iron tank with bellied base. Twelve iron columns with stylized papyrus capitals support the tank and stand on brick piers with bluestone caps. A faceted brick blacksmith's shop with conical sheet metal roof and radial ties is situated at the base. The blacksmith's shop is fitted with a forge and bellows. The tower was completed in 1883 and is of 40,000-gallon [182,000-litre] capacity. At the meeting of the Water Trust held on the 6<sup>th</sup> Feb 1883 it was reported that the tank was full. However

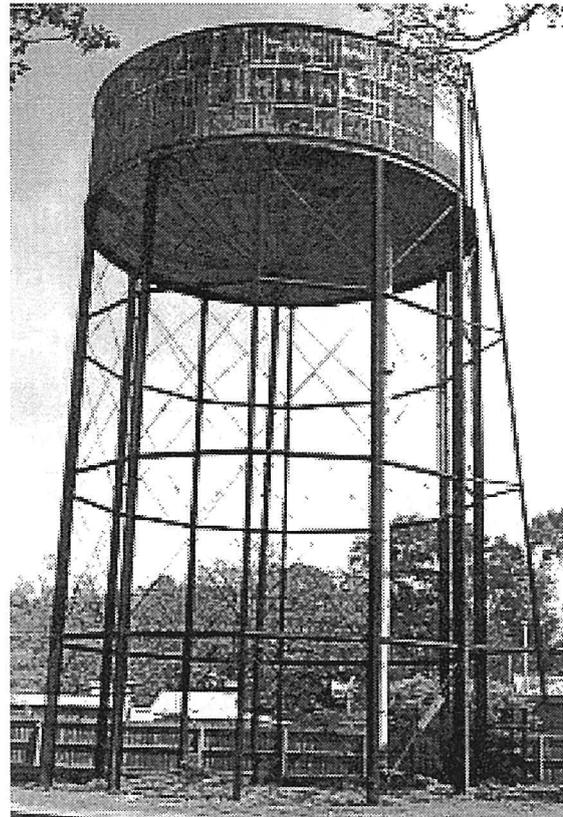
The second tower was erected in 1893 and has a capacity of 40,000 gallons [182,000 litres]. The tower has a riveted steel tank with bellied base and mounted on twelve I-section columns with lateral and cross ties. The tower was opened with a celebration on Monday 22<sup>nd</sup> May 1893.

*Fig 2 The second tower 1893*

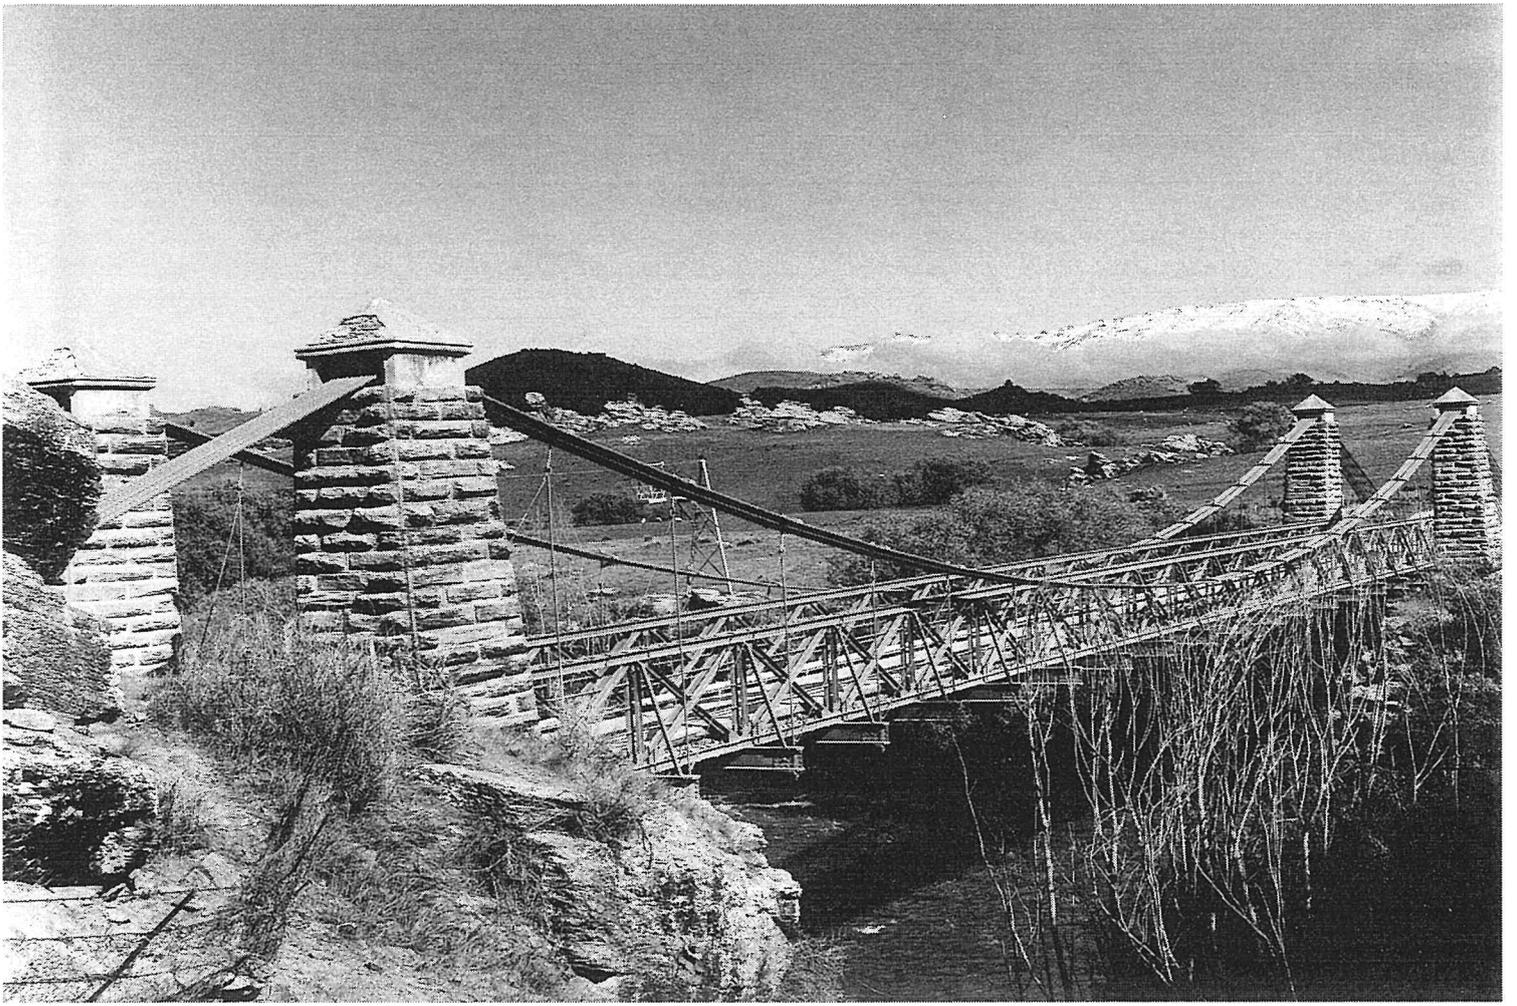
Fig.10 Daniel O'Connell Bridge

Sited on the Manuherikia River at Ophir in Central Otago this bridge was designed by Leslie Duncan Macgeorge, Engineer to the Vincent County. He used schist (the ubiquitous stone in

the region) for the towers with timber deck and stiffening truss. The north anchorage was tied into the solid rock of the approach cutting. The span is 65.53m and width only 3.96 metres. In 1905 the timber work was replaced in steel, but with new timber deck planking. The large number of Irish gold miners in the area decided on the name Daniel O'Connell, the Irish political leader known as "The Liberator".
