Recovering the Waiho

Flood Event: 25th - 27th March 2019

Outline

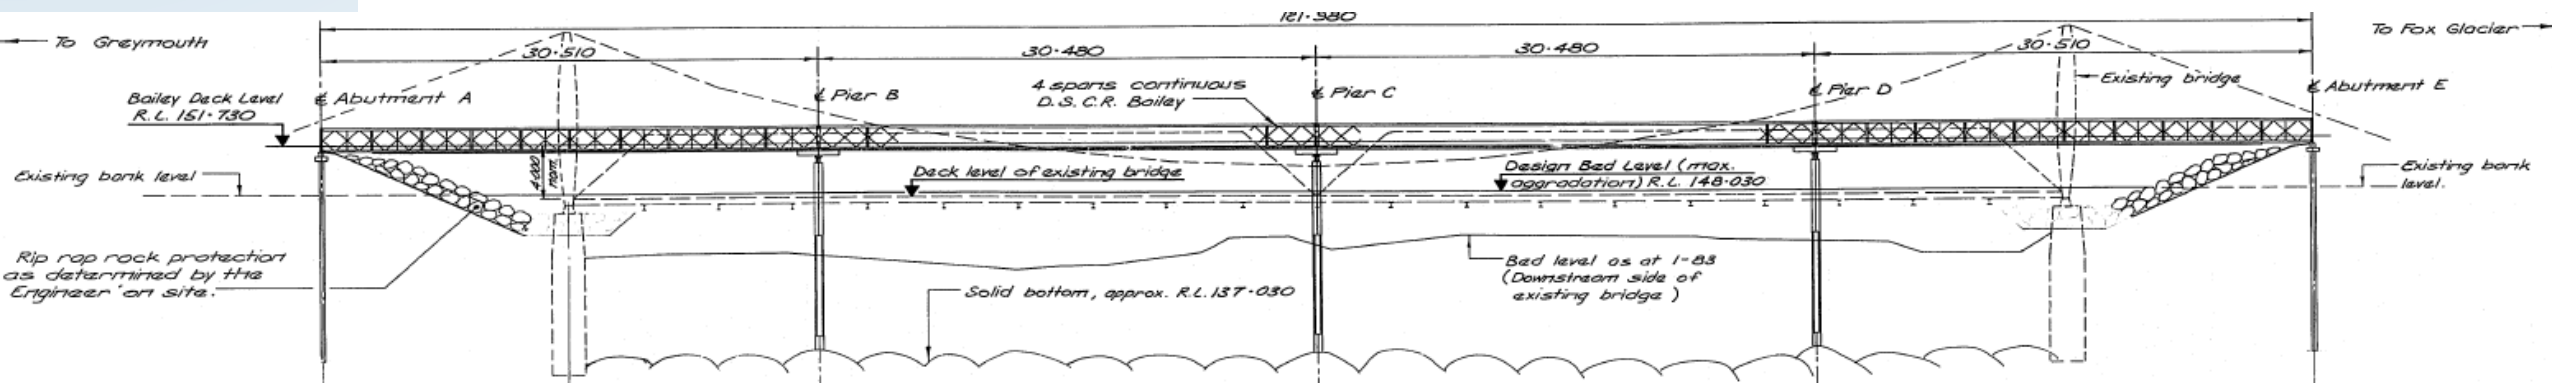
- 1990 – 1991: New Four span Bailey Bridge constructed
- Bailey soffit set around 4m higher than the soffit of the raised suspension bridge

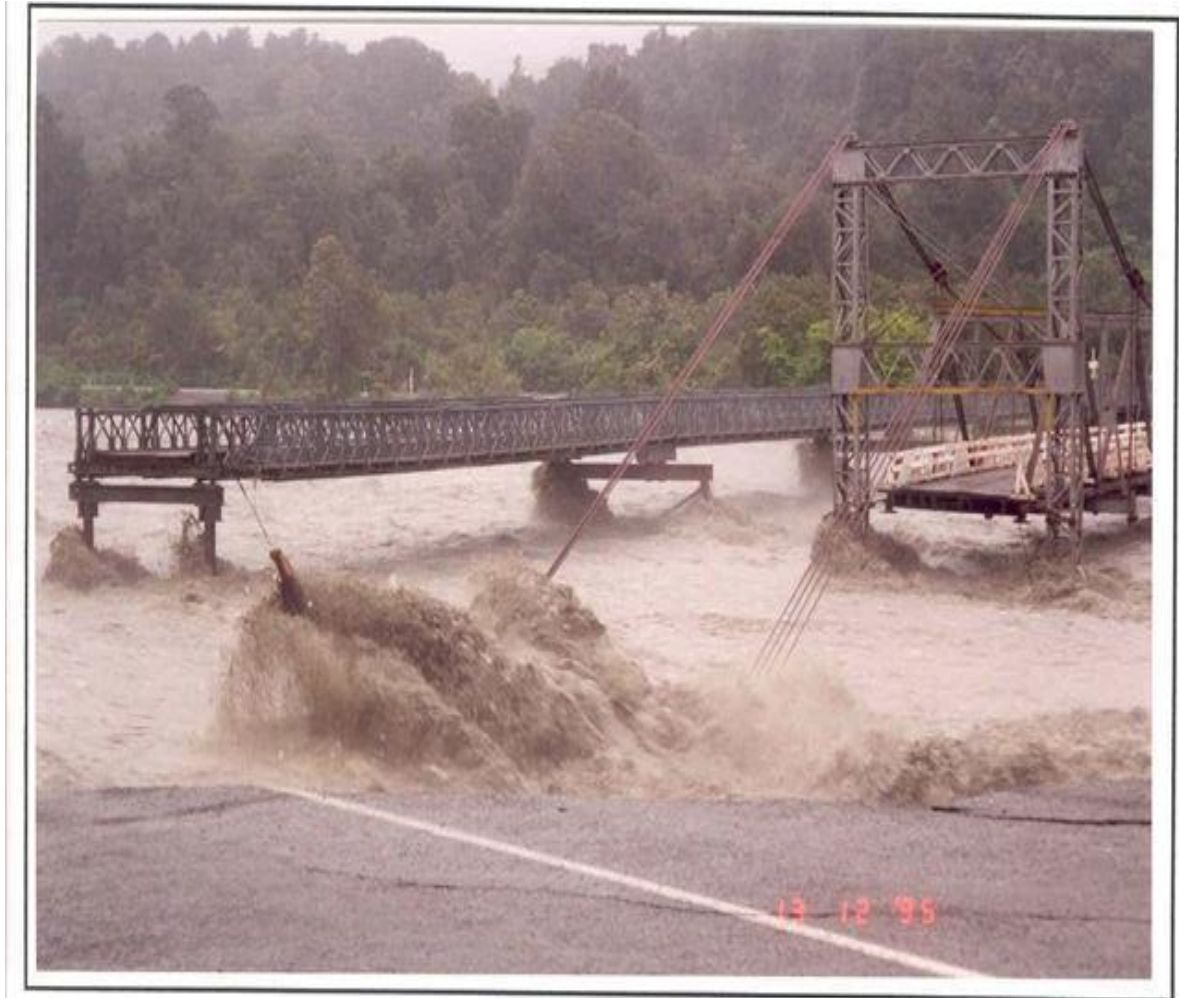
- 1996: Northern approach (true right) washed out.
- Bailey bridge extended by one span to 152m.
- Northern approach and stop-bank reinstated and protected with an improved rock revetment.

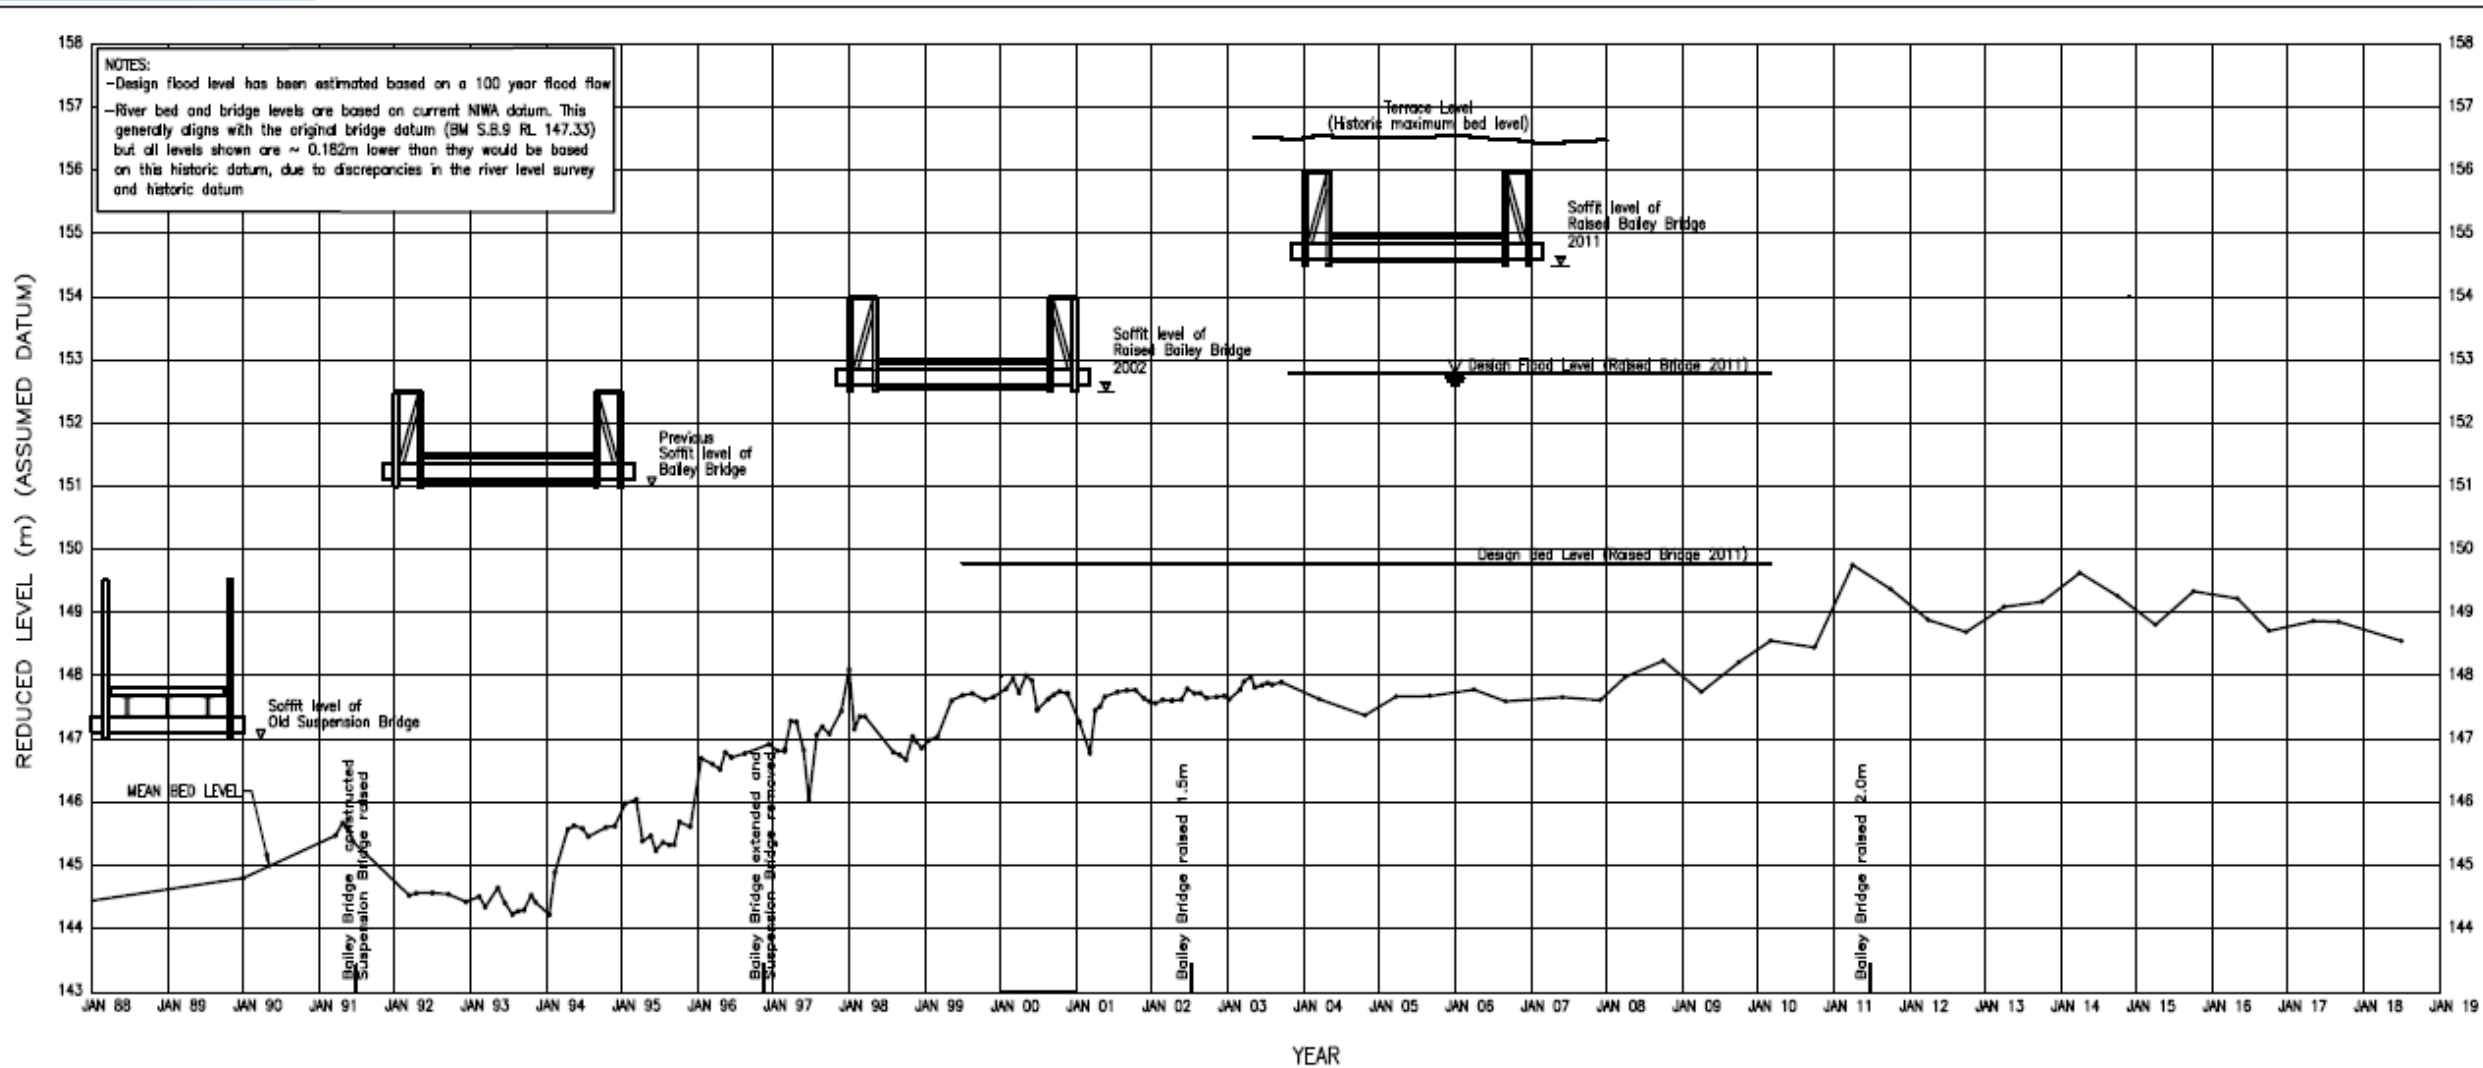
FIGURE 1 – WAIHO RIVER BRIDGE – AGGRADATION OF RIVERBED

latest level on
June 2018

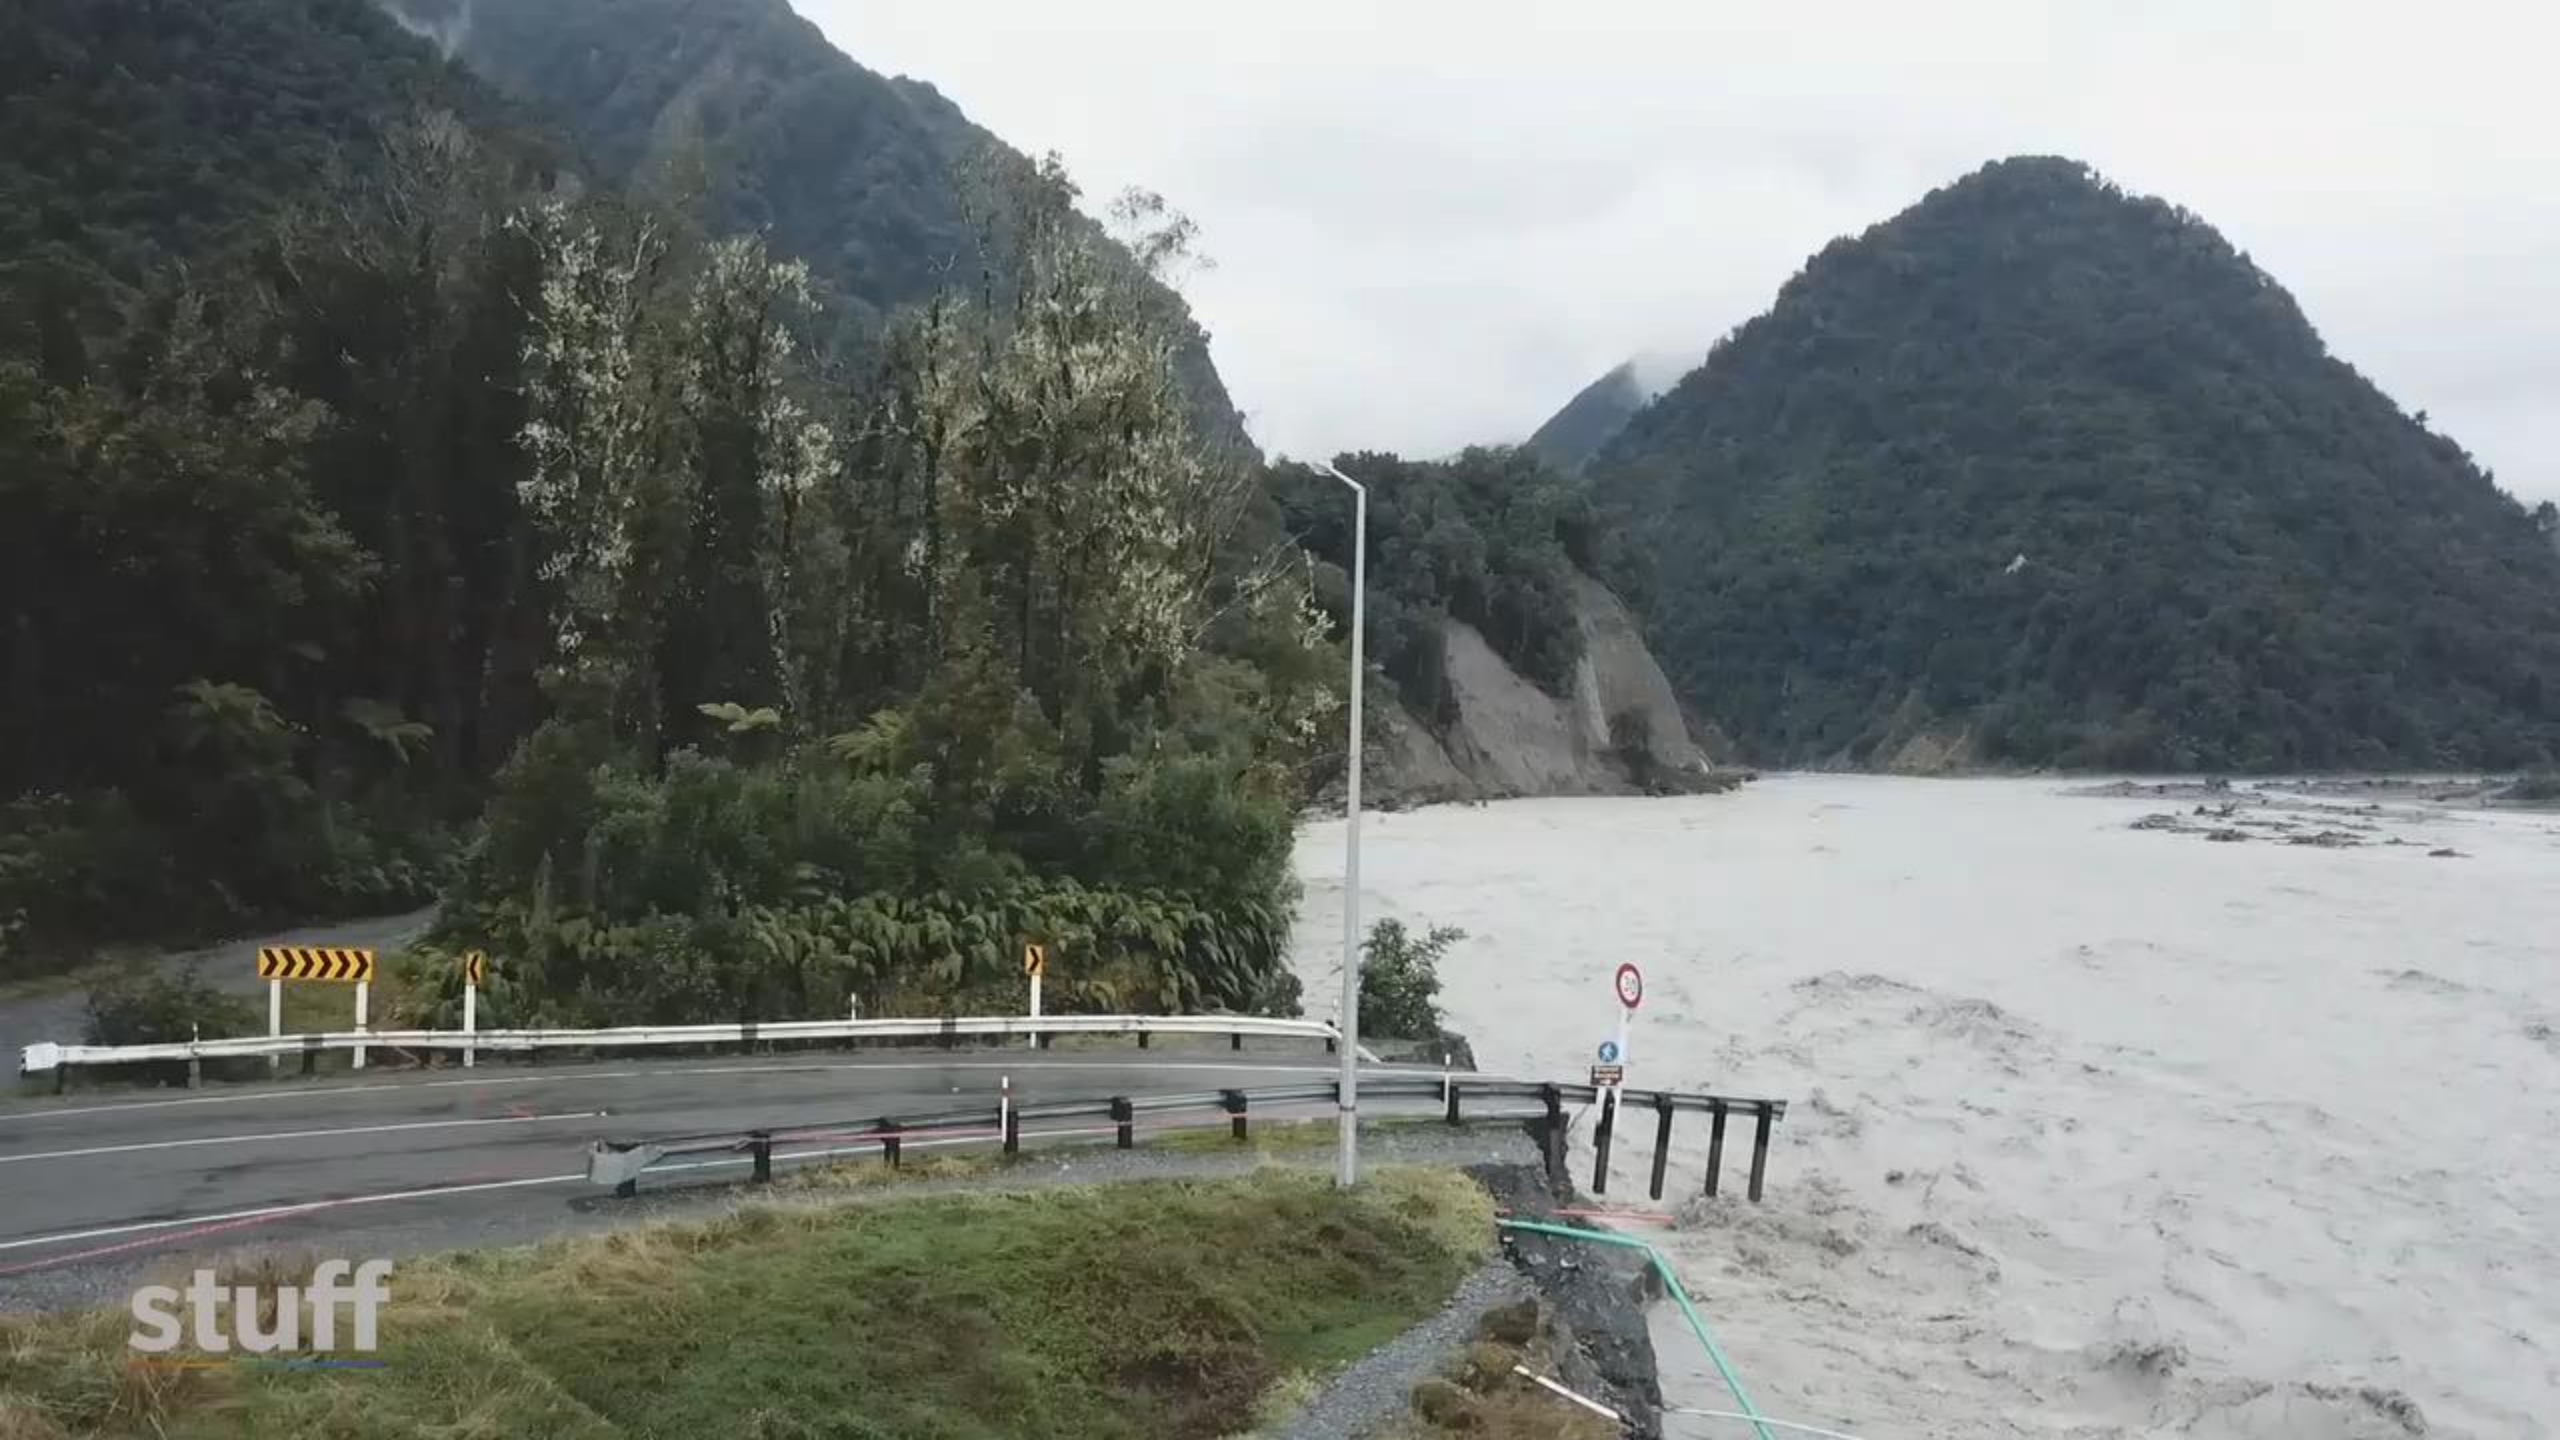
Flood Event - 25th - 27th March 2019

- Massive flood event – some of the highest rainfall ever recorded on the West Coast.
- 506mm rainfall at the bridge site over 48 hours (significantly more in the upper catchment).
- 310mm rainfall in 24 hours at the bridge site
- 114mm in 6 hours
- Flood flow in the order of 1,500 m³/s
- Peak surface river velocities estimated in the order of 5.3m/s
- Bow wave on piers of around 4-5m high!
- Rocks in the order of 1.5m-2m moving down the stream and impacting piers
- Still plenty of freeboard to the bridge (3.6m)

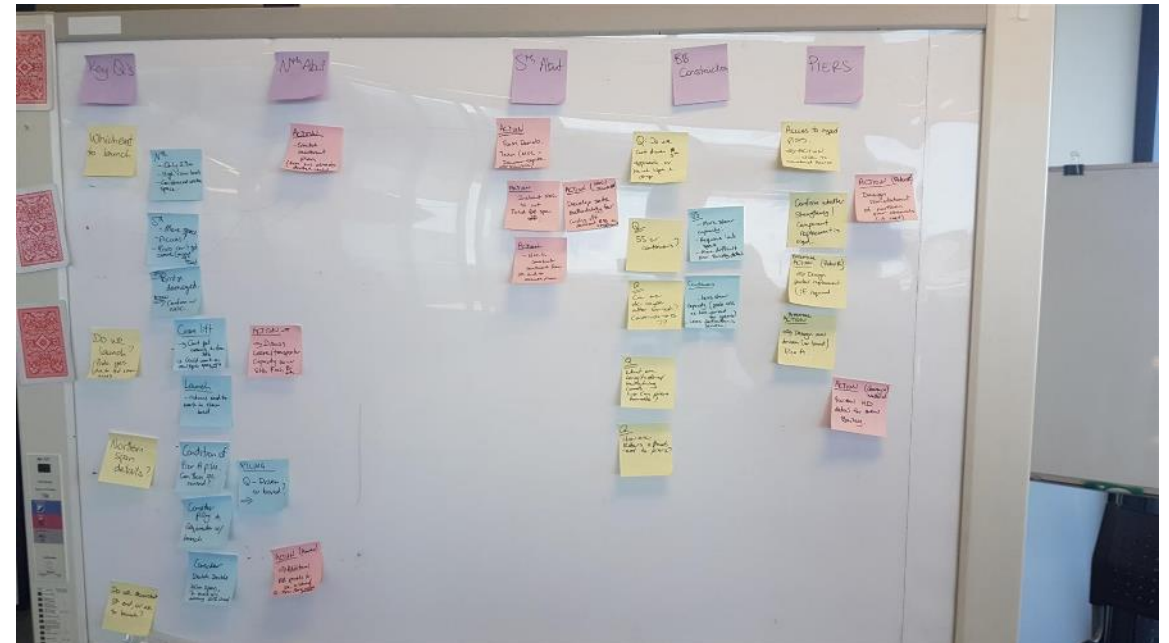
Emergency Response

- \$2-3M cost per day to the West Coast Region
- Key engagement and decisions within the first 24 hours
- Three main work zones
- Everything on the critical path. Contingencies on contingencies

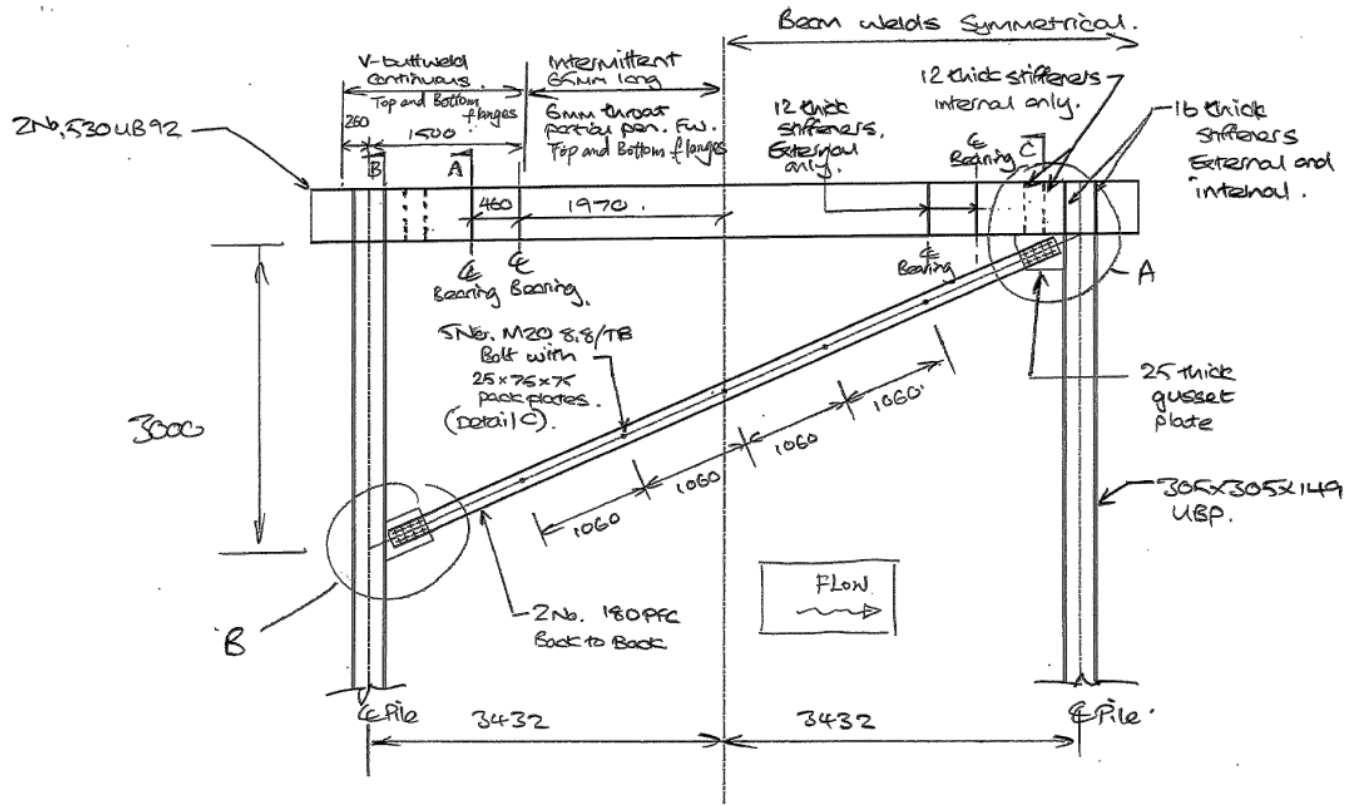
Design - Pier B replacement

ELEVATION - NEW PIER A
NOT TO SCALE
* CONTRACTOR TO CONFIRM DIMENSIONS

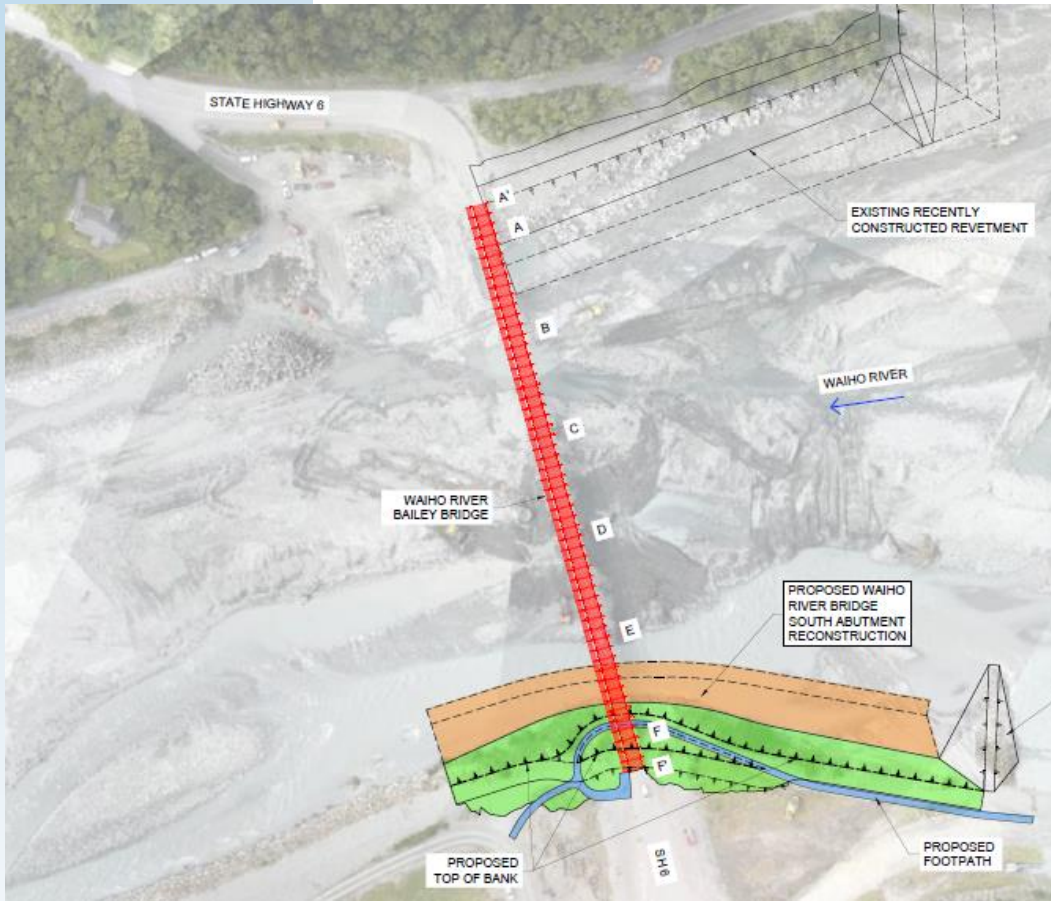
Recovery - Improved Resilience

TYPICAL SECTION - ROCK REVETMENT
SCALE 1:100 (A1) 1:200 (A3)
