IPENZ Engineering Heritage Register Report

Taipo River Bridge Piers, SH73

Date: 5 May 2016. Amended 26 March 2018

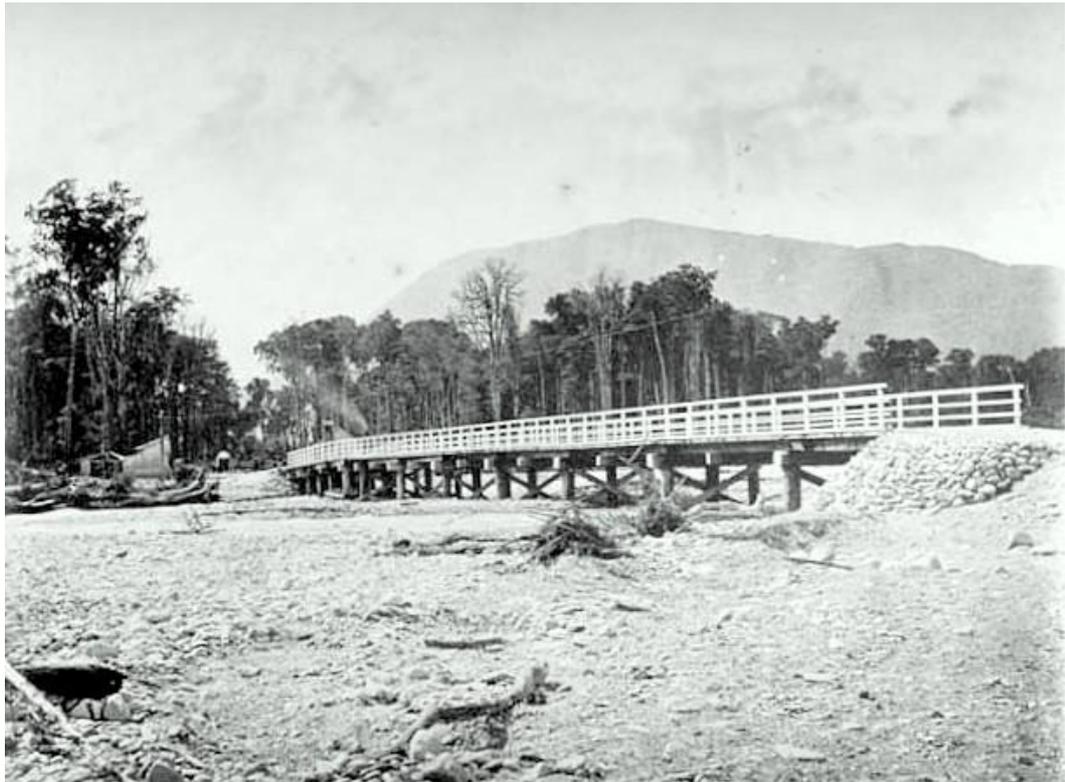
Figure 1: First Bridge over the Taipo River, March 1868. Auckland War Memorial Museum (AM), PH-ALB-86.

The first bridge across the Taipo River was a timber beam-and-girder bridge with eight stringer spans of about 9 meters (m) (**Error! Reference source not found.**)⁵ Tenders for construction of the bridge were called by the Christchurch Public Works Office (PWO) in December 1865.⁶ However, that month there were heavy floods that caused the river to divide into two channels.⁷ The planned bridge crossed only one of these channels. It was decided to persist with construction and divert the river back into the original channel.⁸ In March 1866 Christchurch's *The Press* reported that "...work is now complete as far as that coaches can pass from end to end, except over the Taipo River, where a boat is still used and the coach has to be changed. In a few weeks hence a bridge will complete the whole line."⁹ The bridge was opened in late June 1866.¹⁰

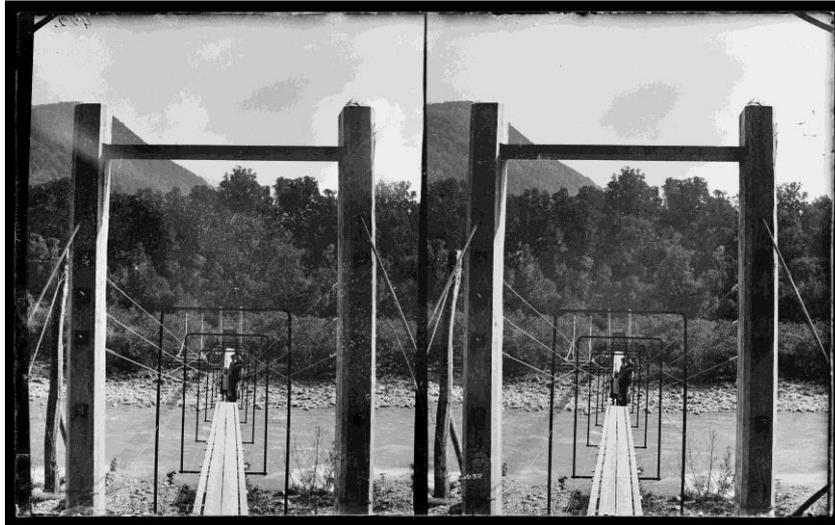
Figure 2: Wire Suspension Bridge over Taipo River. Taipo River, wire bridge, by Burton Brothers studio. Te Papa (C.025195)

Other measures were taken to facilitate continued movement over the Taipo. In December 1868 it was reported that “there had been a very neat wire bridge erected across the Taipo, for the convenience of foot passengers.”¹⁹ (Figure 2) Passengers would cross on this suspension bridge while the coach forded the river. This bridge formed an essential link in the West Coast but was inconvenient and dangerous for travellers and was damaged or washed out multiple times (and presumably repaired/re-built).²⁰ A Canterbury Schoolmaster described his Christmas vacation 1872-1873 experience of the Taipo:

There are three streams to be crossed; the first is by a substantial wooden bridge, the second is easily forded, and for the third the passengers alight and walk across a wire suspension bridge which, though not pleasant, is exceedingly convenient; whilst the driver fords the stream with the empty coach. Two smaller streams are soon afterwards crossed, the Wainini and the Rangiriri, whose waters are very clear, and then the road becomes very rough from the effect of floods.²¹

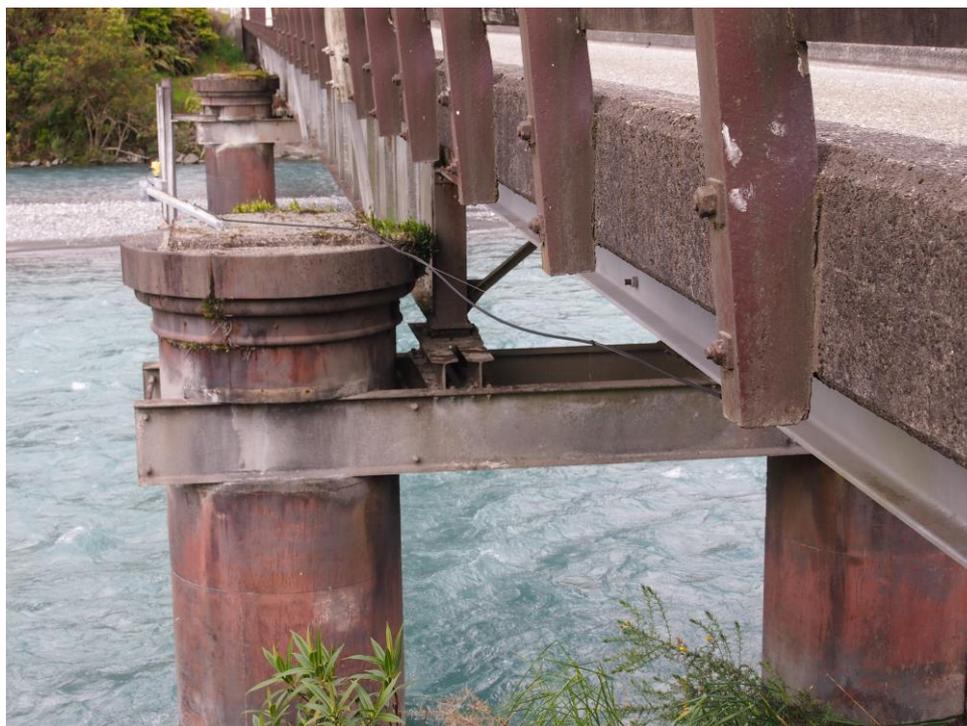
Figure 4: Taipo River Bridge, November 2014. IPENZ.

The existing Taipo River bridge is a single-lane steel plate girder bridge that rests on four of the original eight concrete cylinder piers. Geoffrey Thornton, engineering historian, describes this as ‘a most unusual arrangement.’⁸⁵ The bridge is still used by road traffic on State Highway 73, meaning that it continues to form a critical link for travel to and from the West Coast.⁸⁶

- three 2.4m lengths of cylinder with 1.8m diameter
- one taper ring 1.2 m deep (changing the cylinder diameter between 1.8m and 2.4m); and
- one bottom ring 2.4 m deep with a 2.4 m diameter.⁸⁸ (Figure 4)

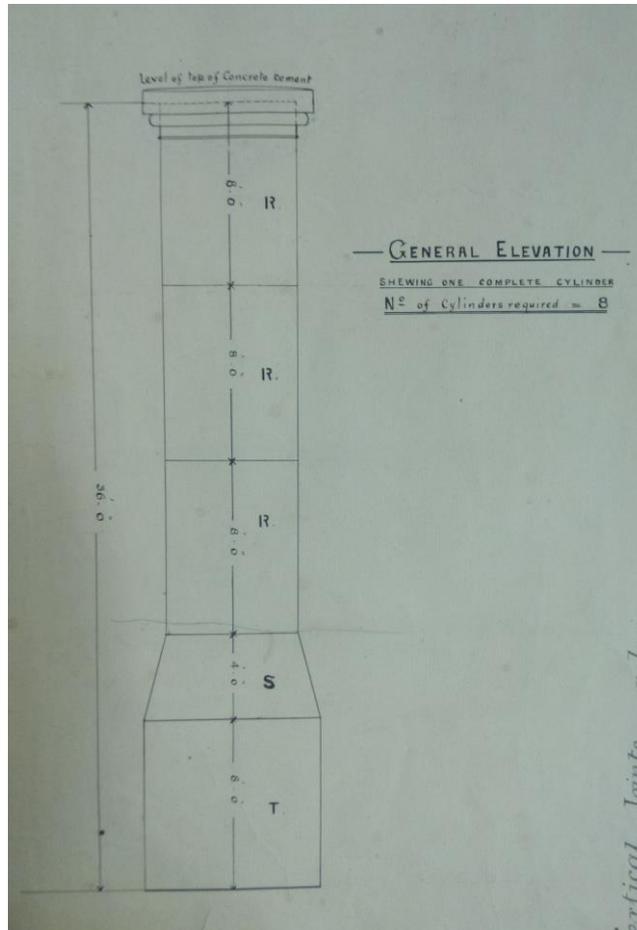
Figure 5: Detail of pier plan, 1885. 'Hokitika-Christchurch Road: Bridge over River Taipo,' Drawing No. 2, Archives New Zealand/Te Rua Mahara o te Kāwanatanga Christchurch Regional Office [Archives Reference: CABA CH86/18; R20231592].

The Taipo River Bridge piers are concrete-filled cast iron cylinders. Only four of the six sets of piers were concrete-filled cylinders, the two extreme piers being bed logs with a concrete foundation at pier number 1 and four timber piles, capped and hooped with iron, at pier number 6.⁸⁷

The cast iron cylinders were 11m tall and specified to be 25mm thick. From top to base, each cylinder consisted of:

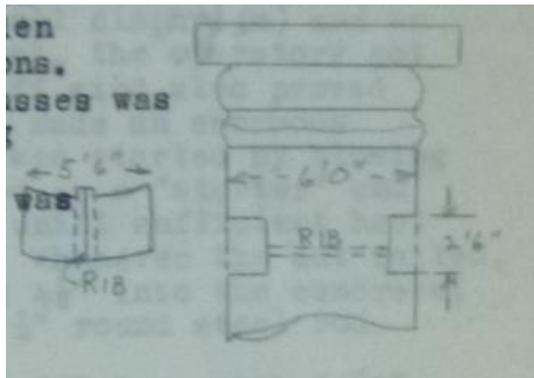
Figure 6: Detail of report on cutting of piers, 1936. 'Cast Iron Cutting Helps Bridge Alterations,' Archives New Zealand/Te Rua Mahara o te Kāwanatanga Christchurch Regional Office [Archives Reference: CABA 3140 CH130/Box77; Archives New Zealand, R20477854].

Following the reconstruction of the bridge in 1935-1936, only four of the original eight concrete-filled cast-iron cylinders remain. Two sets of piers were assimilated into the new abutments and the four remaining piers were modified to hold the steel plate girders. Each segment had two 2'6" by 5'6" segments cut out with oxygen flame (Figure 6).⁹⁵
