OROVILLE DAM INCIDENT - 2017 LESSONS TO BE LEARNT

December 2021

This document summarises the webinar by Brian Benson and David Menéndez Arán who discuss lessons to be learnt from the 2017 Oroville dam incident in California. These are relevant to engineers of all disciplines.

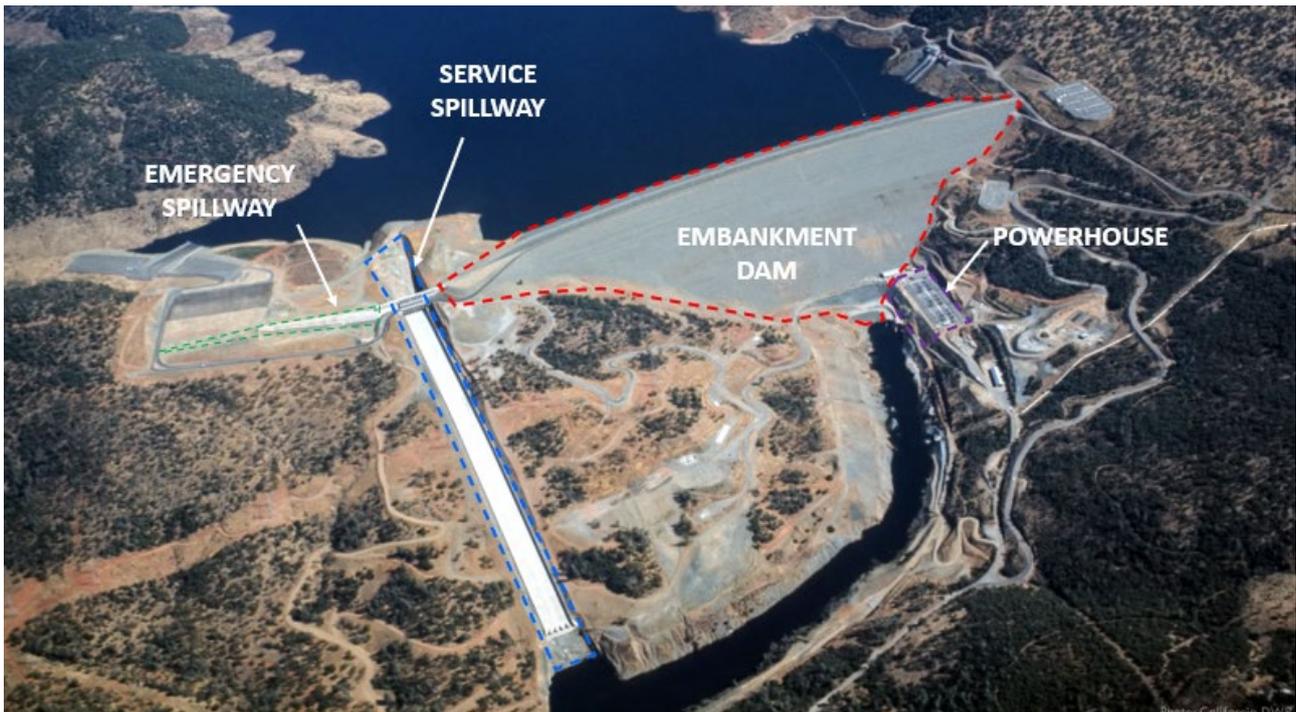
On 7 February 2017 the Oroville Dam spillway chute failed due to flow-induced uplift and extensive erosion occurring in the underlying foundation. Dam personnel decided to close the service spillway gates to control erosion, which increased reservoir levels and meant the emergency spillway was operated. Soon after, erosion occurred downstream which led to the evacuation order.
