# **C5 EVIDENCE PROJECT**

## **PHASE ONE REPORT**

**Evidence of impacts of the technical proposal (yellow) C5 section of the Seismic Assessment Guidelines on a sample of building assessments, and recommendations for further activities in the project's second phase.**

**Prepared for the Ministry of Business, Innovation & Employment.**

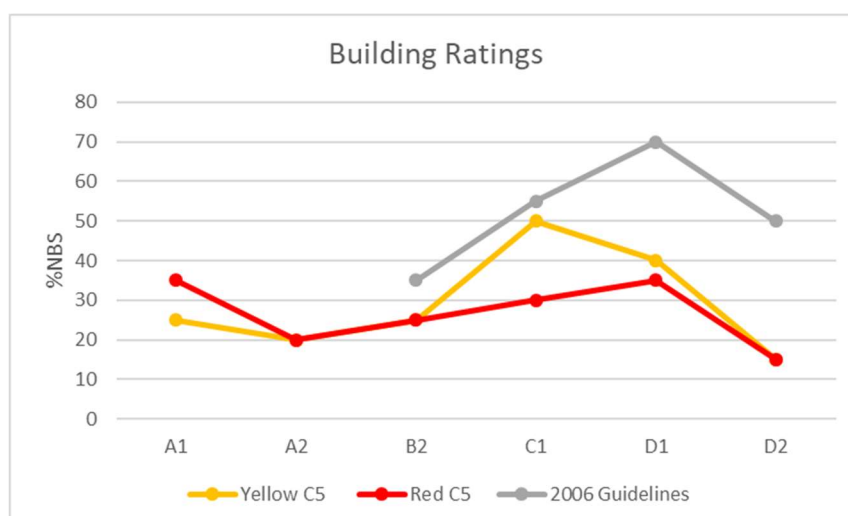
However, the Red Book and Yellow Chapter **identified different vulnerabilities** in buildings. While the overall %NBS results were similar, the scores of building elements were different. Given the Yellow Chapter represents the latest engineering knowledge, this means that retrofits using Red Book assessments may not address the greatest vulnerabilities.

Both the Red Book and Yellow Chapter produce **lower %NBS ratings than the 2006 Guidelines**.

More detail can be seen in [Appendix 1](#).
