# DISCIPLINARY COMMITTEE DECISION COMPLAINT ABOUT KEVIN O'CONNOR

**18 June 2021**

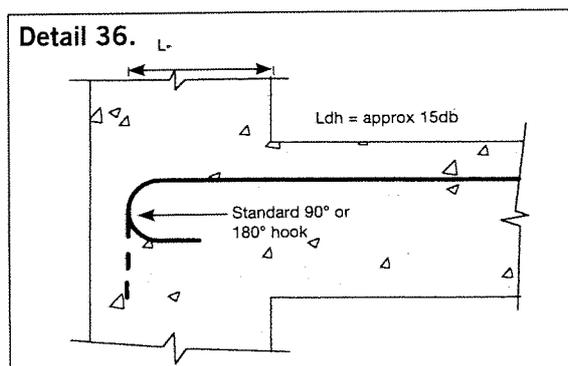
Hooked bars and bent bars have been the standard method of providing anchorage for reinforcing steel in concrete construction where the standard bond length for a straight bar cannot be achieved. Concrete design codes account for this shorter *bond length* by specifying a minimum length,  $L_d$ , from the back of the bend, or hook, to the critical surface. The minimum length equation considers the effect of concrete strength,  $f_c$ , and steel yield strength  $f_y$ .

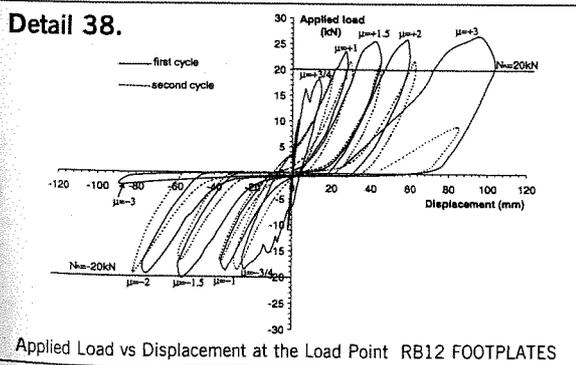
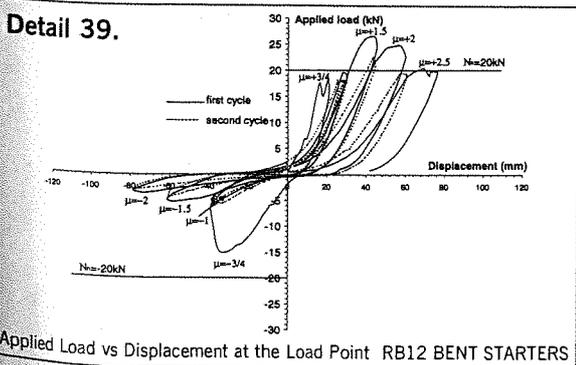
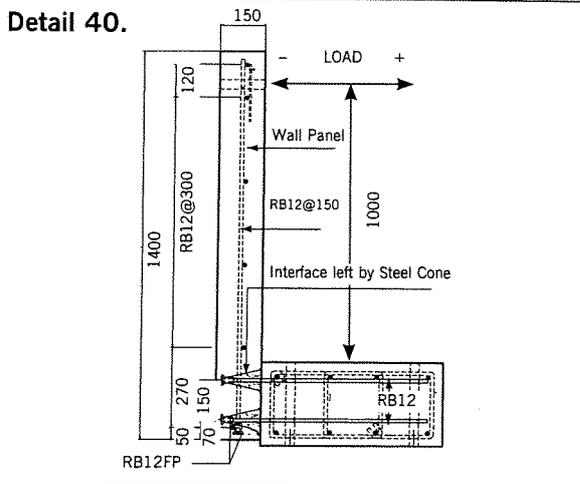
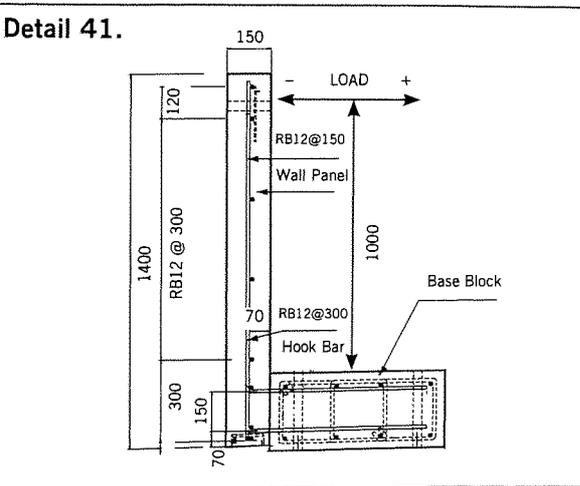
Research at NZ University of Auckland by *Maureen Ma* in 1999 into *Methods of Joining Precast Concrete components to form Structural Walls*<sup>6</sup> highlighted the performance of Reid™ Threaded Inserts compared to that of conventional hooked bar construction. The diagram below shows the test comparison between the two forms of anchorage in a wall panel to footing connection when subject to cyclic loading. It can be seen that the threaded inserts performed significantly better.

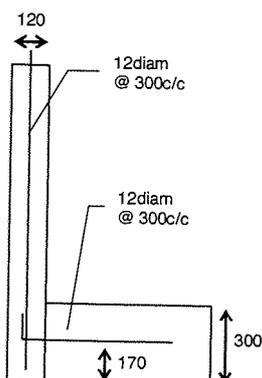
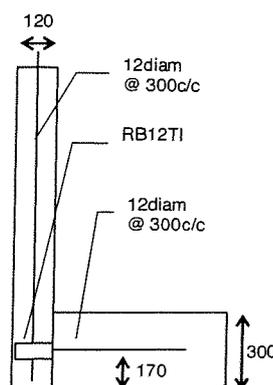
**Hooked bar pullout cone capacity**  $s := 300\text{mm}$

**Threaded Insert pullout cone capacity**

Effective embedment depth of hooked bar  
with cover to starter = 30mm

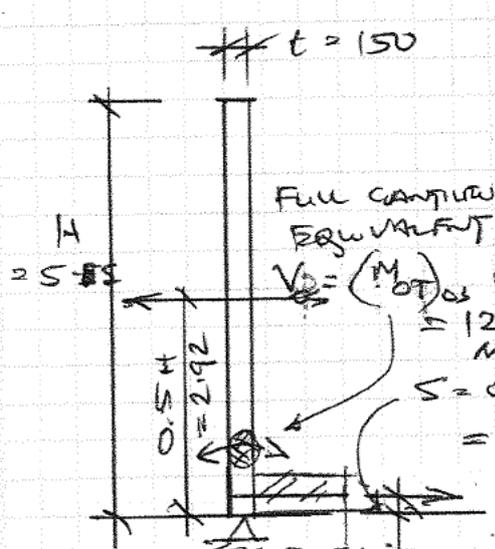
GEOMETRY FOR WALL PANEL / FOUNDATION  
JUNCTION FOR CHECKING FACE LOAD RESISTANCE

1.0m PANEL LENGTH  
 $A_p = 1.0 \times 5.85 = 5.85 \text{ m}^2$   
 $W_p = A_p \times \rho = 5.85 \times 3.6 \text{ kN/m}^3 = 21.1 \text{ kN/m}$

Full cantilever EQUIVALENT  
 $V_p = (M_{OT})_{OS} \cdot \frac{2}{H}$   
 $\leq 12.28 \text{ kN/m}$  MAX  
 $S = 0.5 \times \text{Fdn Depth} = 150 \text{ mm (max)}$

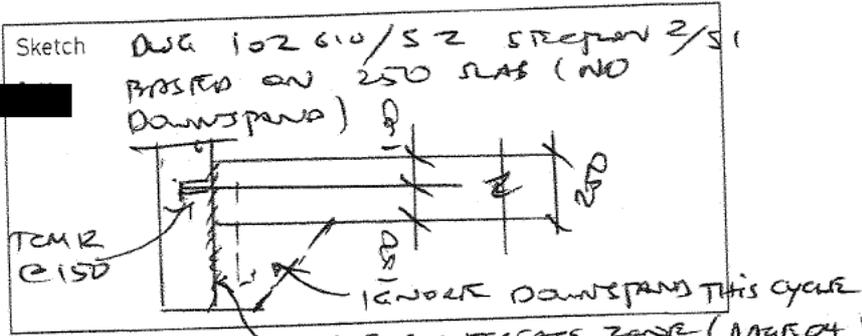
# ANCHORING DESIGN WORKSHEET

Project IRVINE MASTRIPAN  
 Design 408 Queen St  
 Location GRID A/1-4  
 Project ID KOA 102610  
 Design by BJS  
 Date 1/5/17  
 Checked \_\_\_\_\_

*DEMAND SPECIFICALLY FOR PANEL M OS CAPACITY CASE*  
 N\* & V\* are the per anchor load demand.  
 Check both external and internal anchors for suitability.

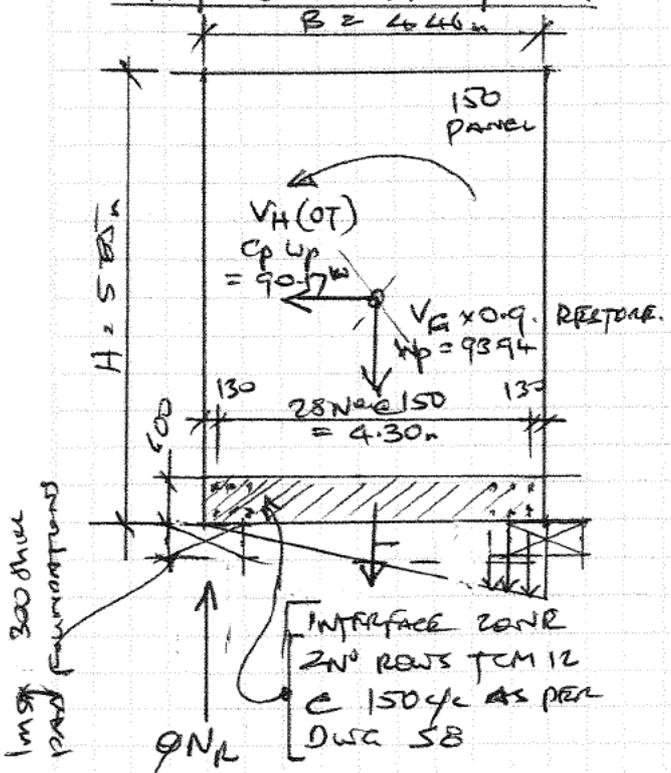
GEOMETRY FOR WALL PANEL / FOUNDATION  
INTERFACED WITH CIRCULAR END PLANE  
OVERTURNING RESISTANCE:

Maximum  
 panel  
 on 1000 sq  
 foundation  
 pads.

ADD TO TCM  $V_{TCM}$  THE RESISTANCE  
 TO  $V_H(OT) = 90.17kN$  FROM  
 HORIZONTAL BRACE STIFFNESS

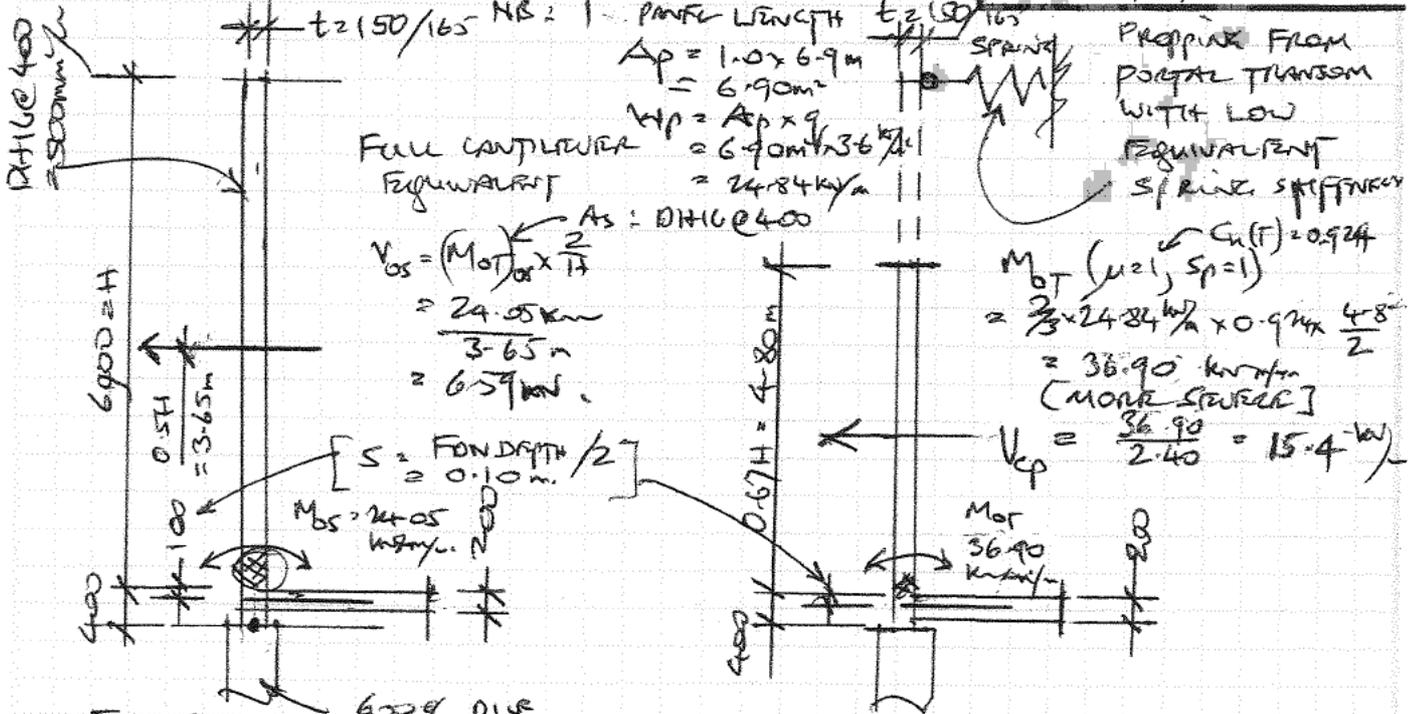
1. Geometry for wall panel / foundation junction  
 For calculation of factored load moment resistance

t2150/165 NB: 1. Panel length  
 $A_p = 1.0 \times 6.9 \text{ m} = 6.9 \text{ m}^2$   
 $A_p = 6.9 \text{ m}^2$   
 $A_p = 6.9 \text{ m}^2 \times 36 \text{ kN/m} = 248.4 \text{ kN}$   
 Full cantilever equivalent  
 $A_s = \text{D116@400}$   
 $V_{os} = (M_{ot})_{or} \times \frac{2}{H}$   
 $= \frac{24.05 \text{ kN}}{3.65 \text{ m}} = 6.59 \text{ kN}$

PROPPED FROM PORTAL TRANSFORM WITH LOW EQUIVALENT SPRING STIFFNESS  
 $C_{it}(T) = 0.924$   
 $M_{ot} (\mu=1, Sp=1)$   
 $= \frac{2}{3} \times 248.4 \text{ kN} \times 0.924 \times \frac{4.8}{2}$   
 $= 36.90 \text{ kNm}$   
 (MORE STIFFER)  
 $V_{cp} = \frac{36.90}{2.40} = 15.4 \text{ kN}$

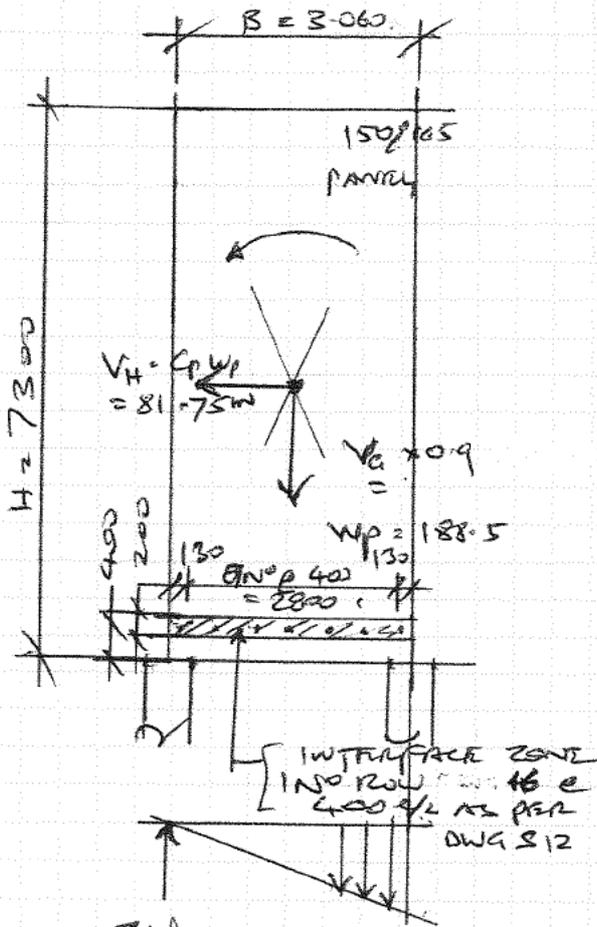
GEOMETRY FOR WALL PANEL / FOUNDATION JUNCTION WITH CHECKING IN PLANE OVERTURNING RESISTANCE.

Ø Ne.  
 Rotation point on 600 dia foundation piles.

ADD TO  $(V_{TCM})_H$  THE IN PLANE RESISTANCE TO  $V_H = 81.75kN$  FROM HORIZONTAL BRACE SHEAR

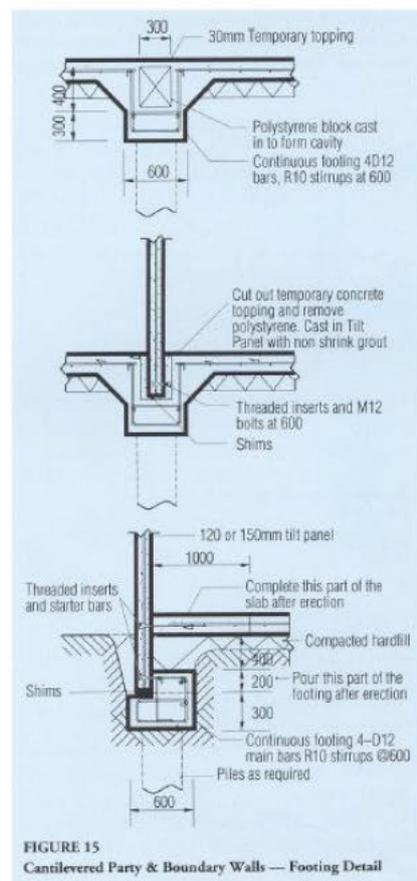
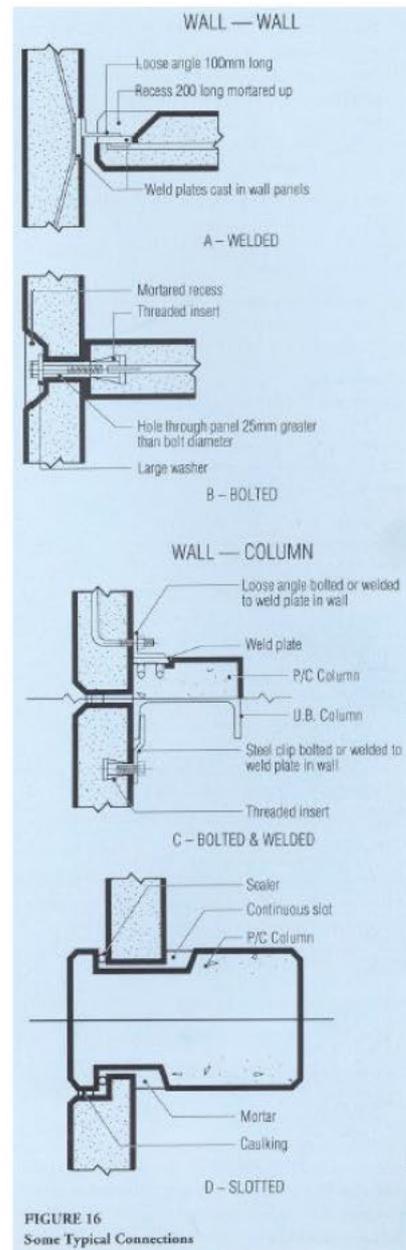
Spalling may occur if shims are located too close to the end of the panel, 300 mm is the recommended minimum distance. The size of the shims used should be determined by the load-carrying capacity of the shims and the bearing capacity of the concrete panel. They should not exceed 40 mm in height and should be not less than the width of the panel or 100 mm, whichever is less.

Other typical fixing and seating details are shown in Figures 15 and 16.

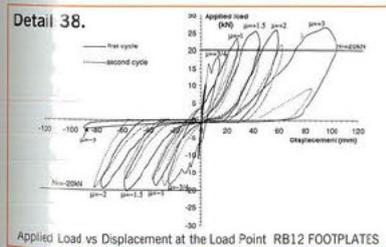
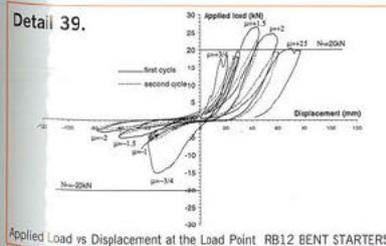
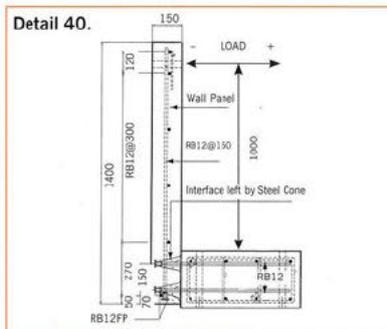
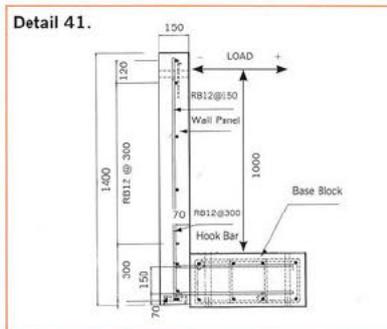
Figure 3 - Extract from Reid Design Guide

Research at NZ University of Auckland by Maureen Ma in 1999 into *Methods of Joining Precast Concrete components to form Structural Walls* highlighted the performance of Reid™ Threaded Inserts compared to that of conventional hooked bar construction. The diagram below shows the test comparison between the two forms of anchorage in a wall panel to footing connection when subject to cyclic loading. It can be seen that the threaded inserts performed significantly better.
