TAMING AND DEVELOPING THE COASTAL MARGINS OF AOTEAROA LESSONS TO BE LEARNT

April 2022

This document summarises the webinar by Dr Rob Bell FEngNZ CPEng in conjunction with the New Zealand Coastal Society.

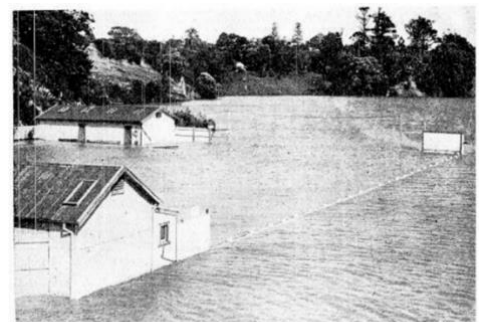
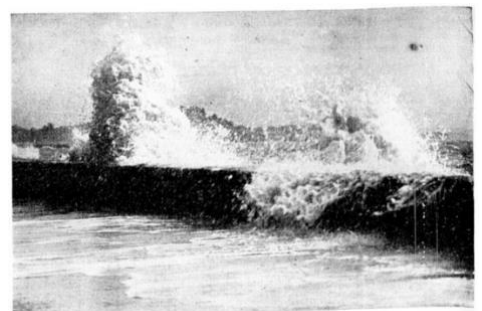
NZ Herald 27 March 1936

Parnell Baths - Judges Bay (2 ft above baths)

A typical scene on the Kohimarama waterfront at high tide yesterday morning.

In 1936 a large strong tide event caused coastal flooding at Kohimarama in Auckland. It flooded the Parnell Baths and across the waterfront and caused extensive damage.

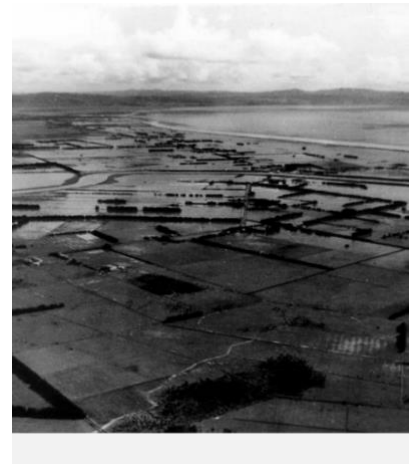
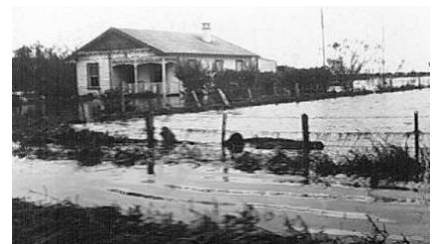
Sixteen hundred hectares of the plains were flooded, at depths of 0.5 -1.3 metres. The flooding also overtopped coastal and Piako River stopbanks, and the outflow of the water breached sizeable sections of the road (caused by the combined force of the land drainage and outflowing at the same time as the tide dropping).

This event led to raising of the coastal stop bank.

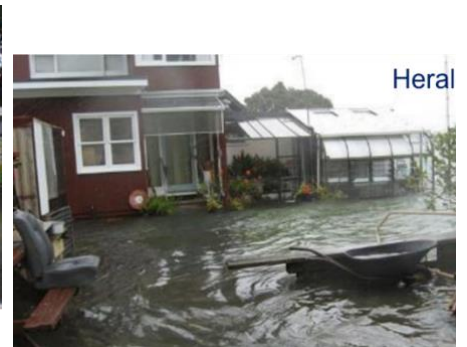
SH16 Waterview Causeway (NZTA/AMA)

On 23 January 2011, Auckland experienced its highest storm tide. State Highway 16 Waterview Causeway had to shut for three hours until debris was cleared. The following factors were found to have contributed to the flooding of the Waterview Causeway:

- the ongoing subsidence of the marine muds on which the motorway sits;
- the low rock wall which was overtopped by small waves;
- sea-level rise (SLR); and
- a high spring tide and storm surge from a low-pressure system.

As a result of a New Zealand Transport Agency (Waka Kotahi) funded project, the causeway was widened and raised factoring in an allowance for sea-level rise of 0.8 m, with sufficient footprint and ground treatment to enable a further half metre rise in the road elevation (if required).

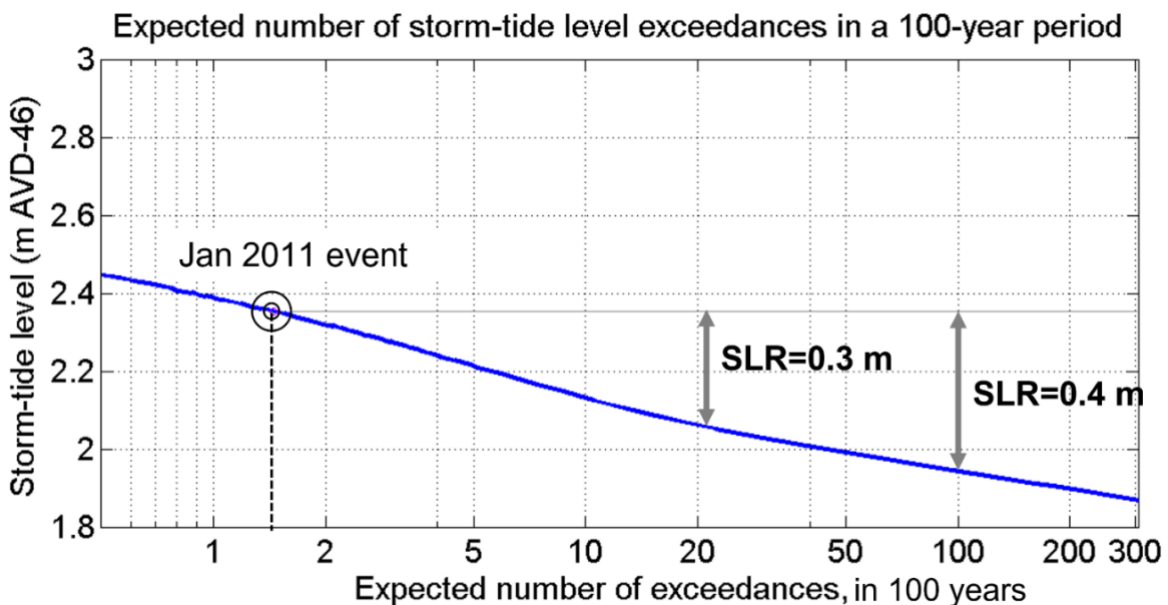
This graph shows the historic extreme distribution of storm tide levels for Tāmaki Makarau in terms of the number exceedances of coastal floods for different storm tide levels over a 100-year period. Note: this would be a similar pattern for other parts of the country.

While the 2011 coastal flooding was approximately a 1:100-year event, from now on (taking into account SLR) the same flooding would happen with smaller and smaller storm tide levels. By the time there is a 0.4 m SLR in Auckland, there will be:

- around 100 **extreme** storm occurrences like the 2011 event. This equates to one a year on average.
- many more **moderate** nuisance flooding events.

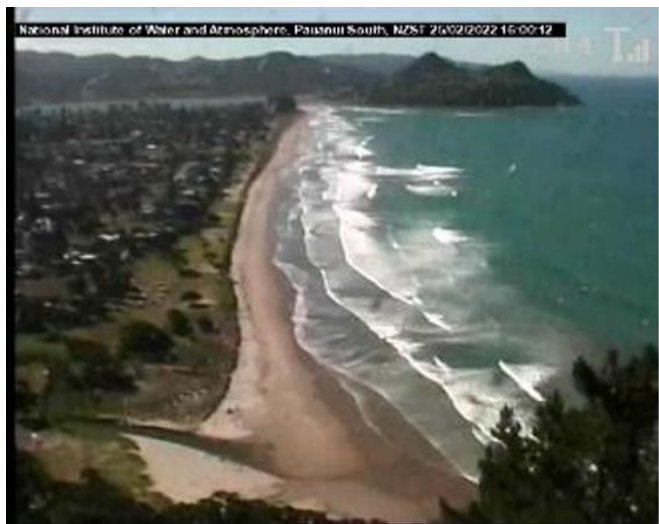
Source: [NIWA CamEra web page](#)

The Ministry of Works' Water and Soil Division assisted councils with technical support for coastal areas including groundwork studies and surveys of the Pauanui spit in Coromandel Peninsula [Gibb & Aburn (1986)]. While working for the Water and Soil Division, I was involved in undertaking oceanographic and survey measurements. The purpose was to create the first coastal hazard zone determination in New Zealand (1986) incorporating an allowance for SLR, that could be used to set the seaward boundary of development of the spit.

As a result, a SLR allowance of 0.7 metre was built into a set back zone for the Pauanui development. At the time it was estimated that this would last from 1983 to 2080 (a hundred-year period).

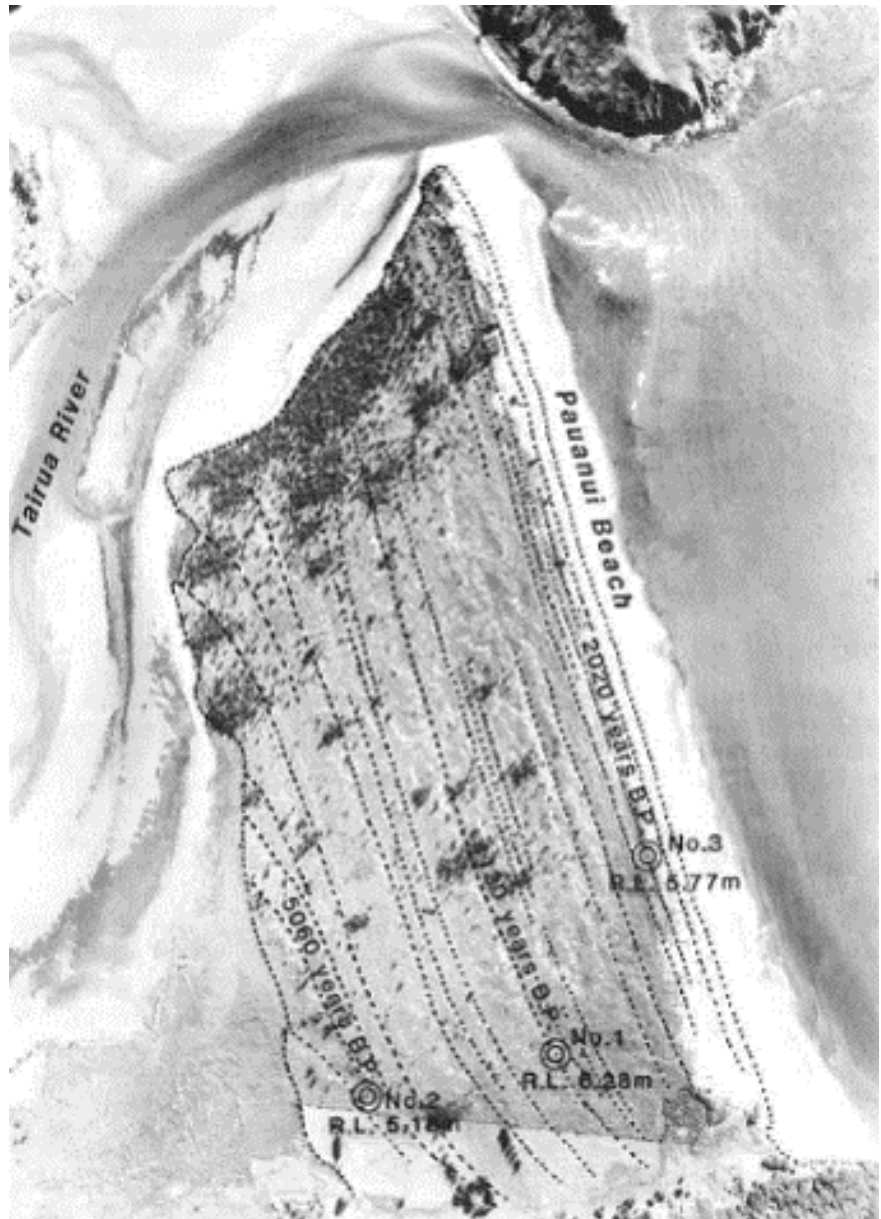
WATER & SOIL TECHNICAL PUBLICATION NO. 27
WELLINGTON 1986

Shoreline fluctuations and an assessment of a
Coastal Hazard Zone along Pauanui Beach, Eastern
Coromandel Peninsula, New Zealand
