IPENZ Engineering Heritage Register Report

Rakaia Gorge Bridge, Windwhistle

Written by: Karen Astwood
Date: Last amended 10 June 2013

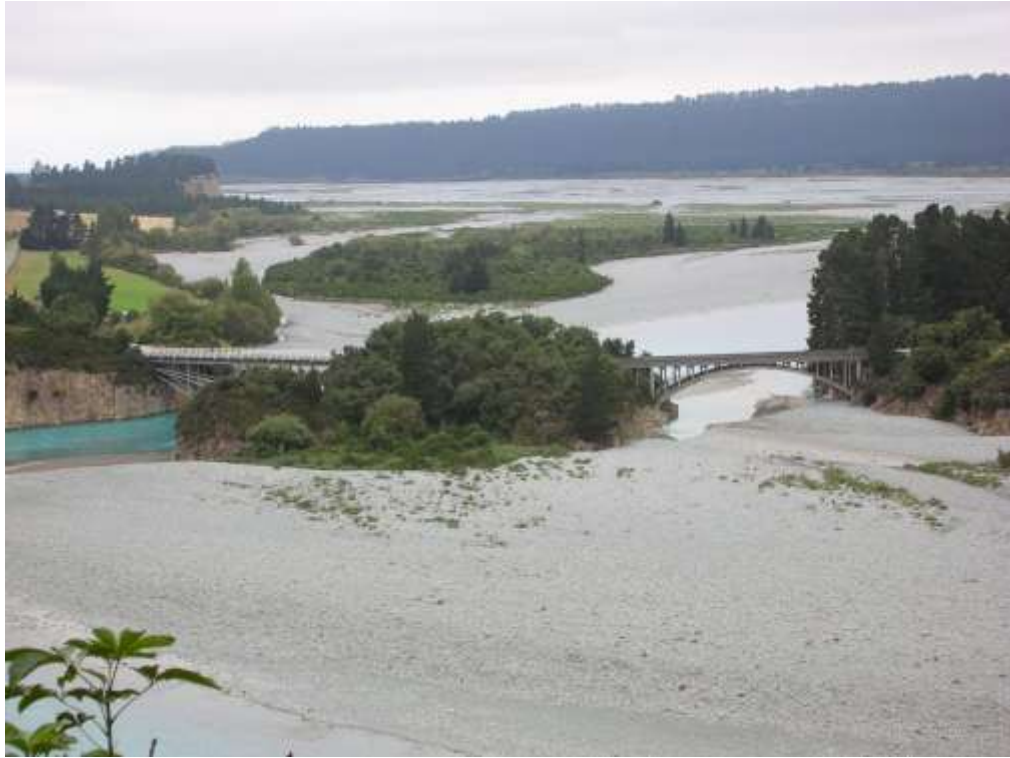
Figure 1: Rakaia Gorge Bridge (left) and the flood channel bridge (right), February 2007. Image courtesy of Lloyd Smith
